# Your Inspection Report

2014 Lola Lane  
Ludoville, GA 30114

**INSPECTION DATE:**  
Sunday, March 6, 2022

**PREPARED BY:**  
Glen Williams

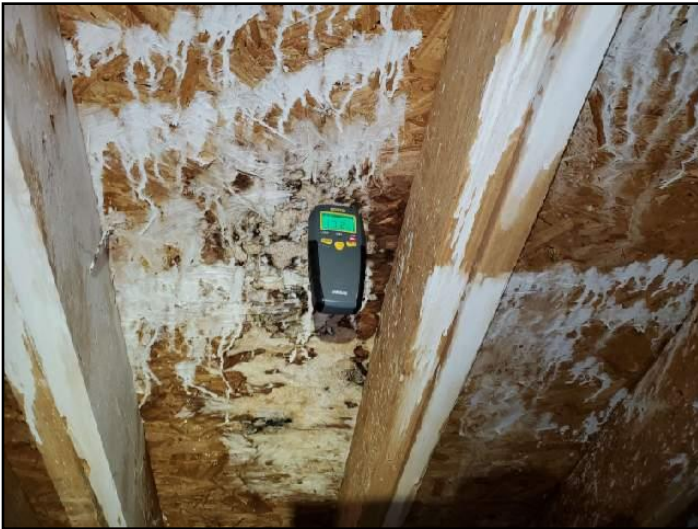
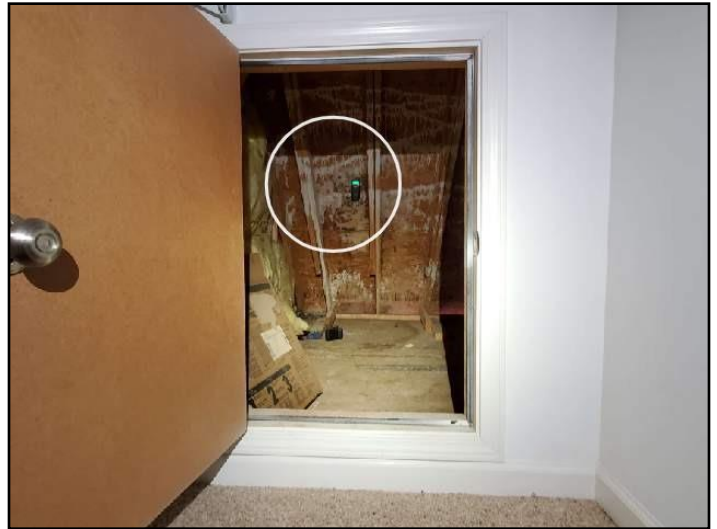
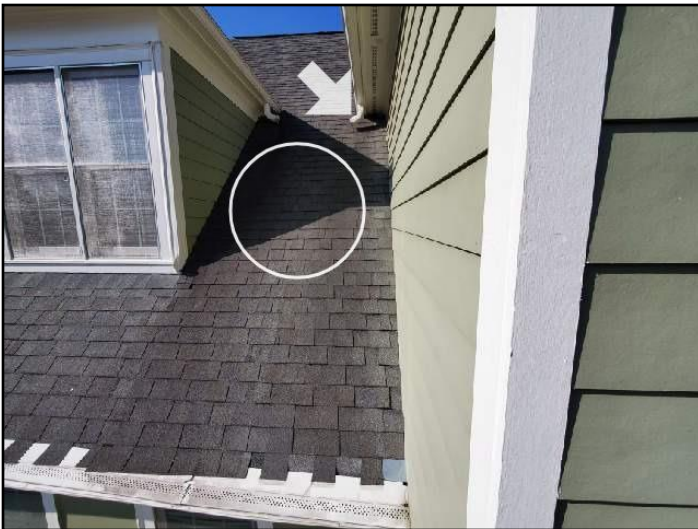
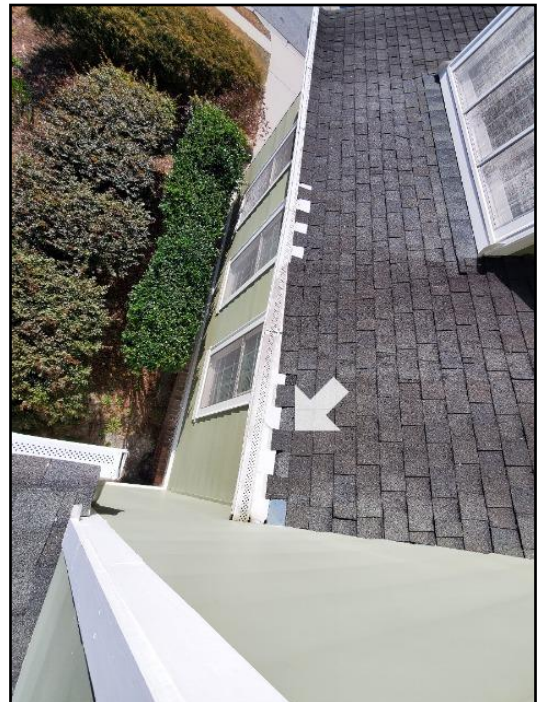
Some moisture is suspected to be penetrating the roof where there is a downspout discharging. Ice and water shield may be recommended at this location and possibly sheathing replacement (Or cleaning). While the roofers are present some corrections to the shingles may be necessary at the rear of the home where there is damage to the eaves most likely from the gutter guards or shingles that overhang the ends of the gutters.

1. Elevated moisture and fungal growth

2. Leak

4. Shingles missing

**Task:** Recommend a roofing contractor for evaluation

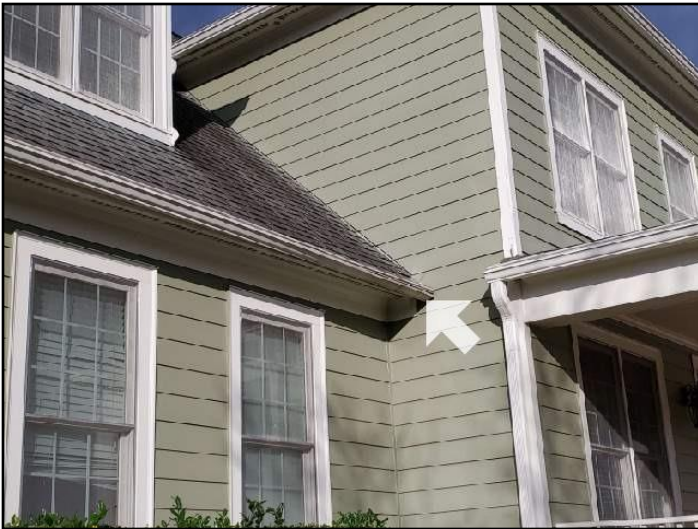
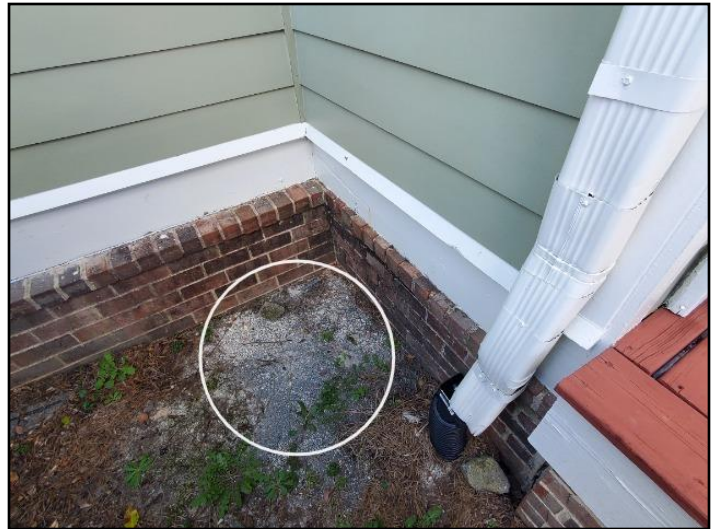
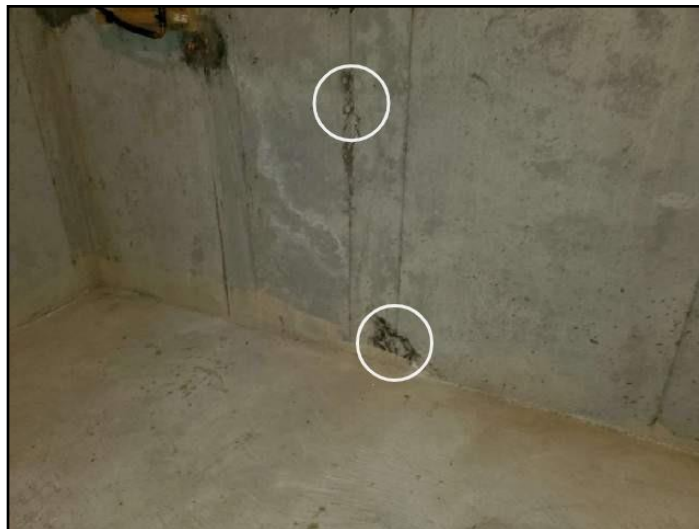
The gutter is loose at the front of the home and allowing excess roof runoff to discharge onto the front of the home. It's caused the below grade downspout to settle and detach from the downspout exacerbating the issue. Some slight elevated moisture is evident at the foundation wall at the interior as a result. It's recommended to re-secure the gutter and reconnect the downspout.

6. Loose

7. Roof runoff ponding here

8. Minor moisture

**Task:** Recommend correction by a gutter contractor

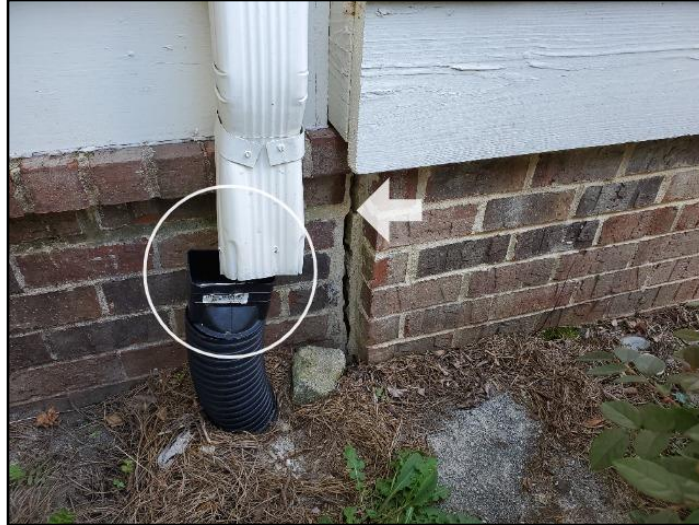
Recommend reconnecting the downspout and sealing the joint at the porch and main structure. Roof runoff has been

cascading over the side of the roof and has caused the below grade downspout to settling and has also caused some settling. The gutter guard may not be ideal at this location.

9. Connections loose

**Task:** Recommend correction

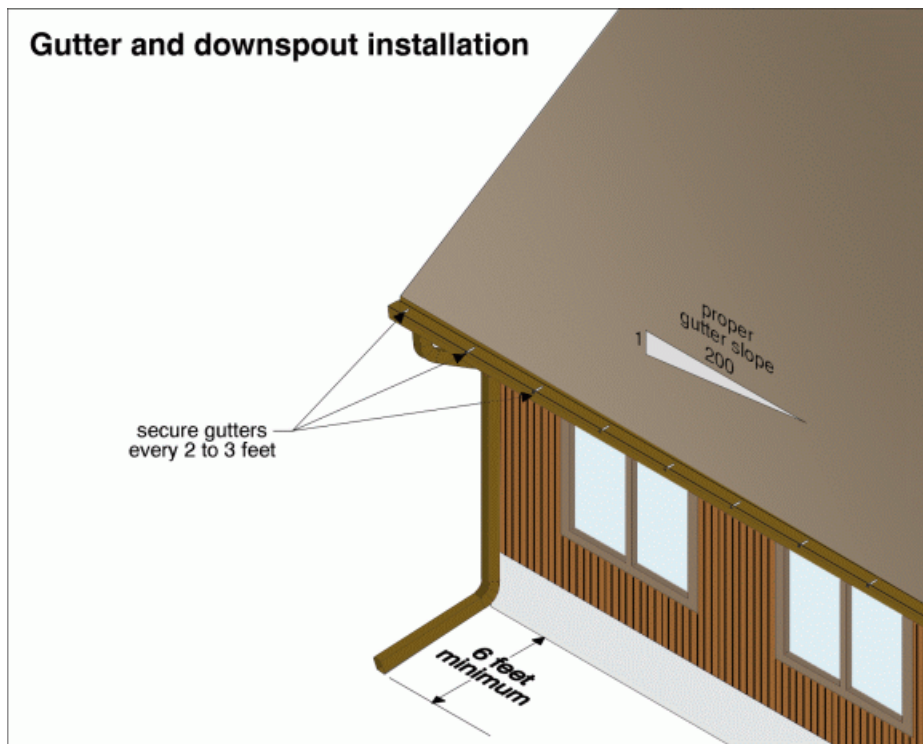
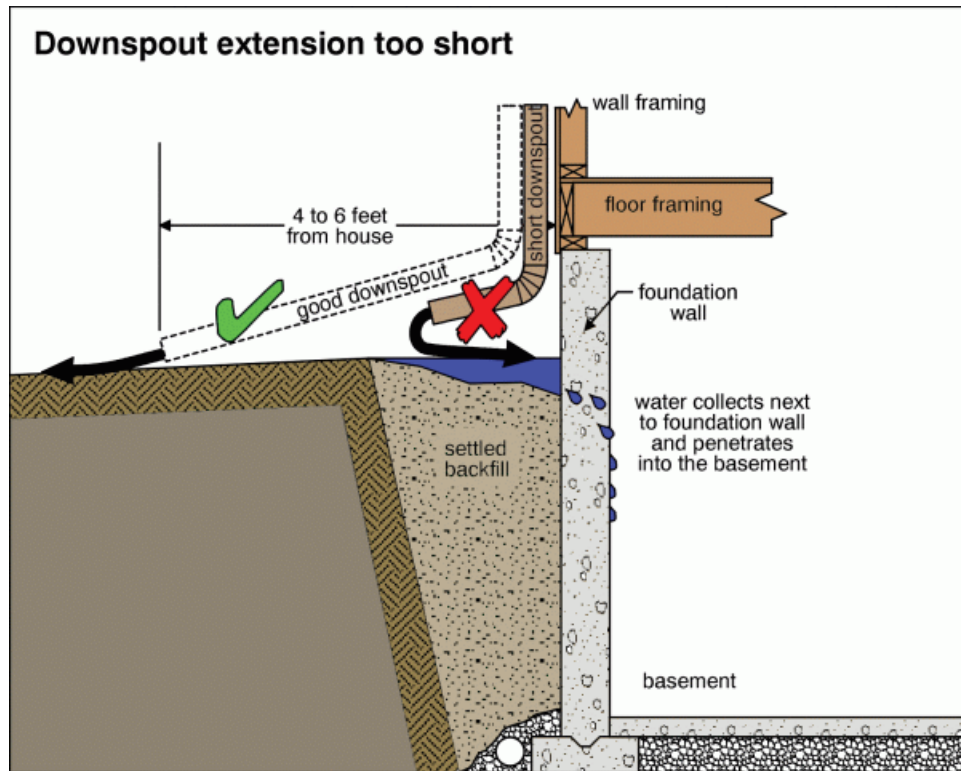
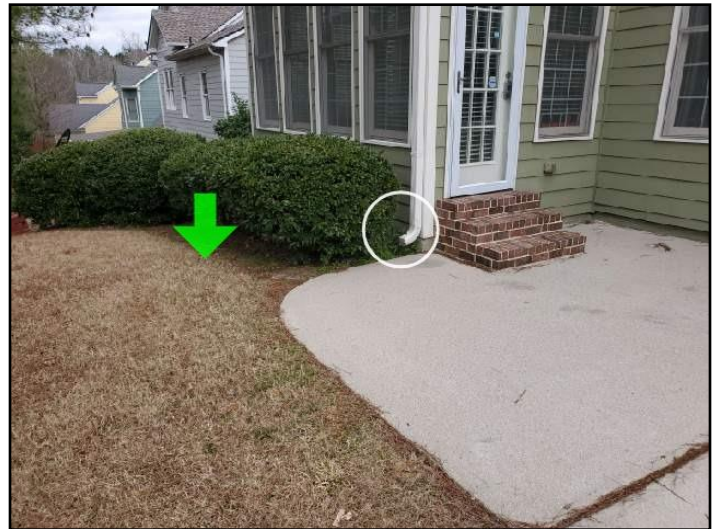
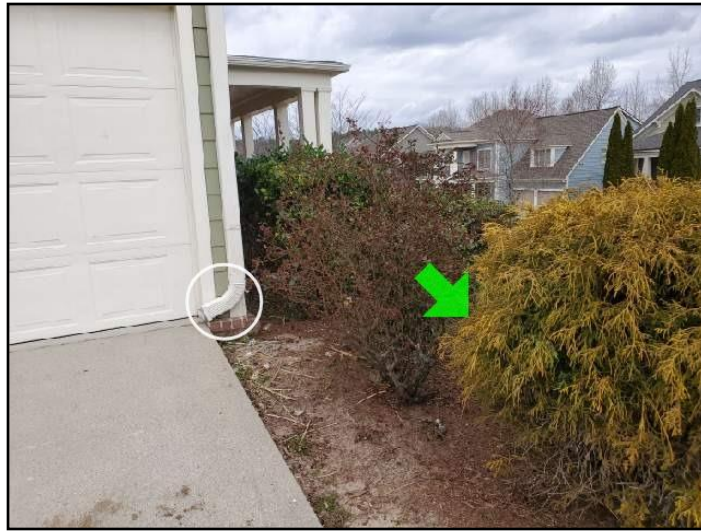
It's recommended to correct all downspouts that are discharging too close to the home with extensions.

10. Discharge too close to building

11. Discharge too close to building

12. Recommend a 180 at the elbow

**Task:** Recommend correction

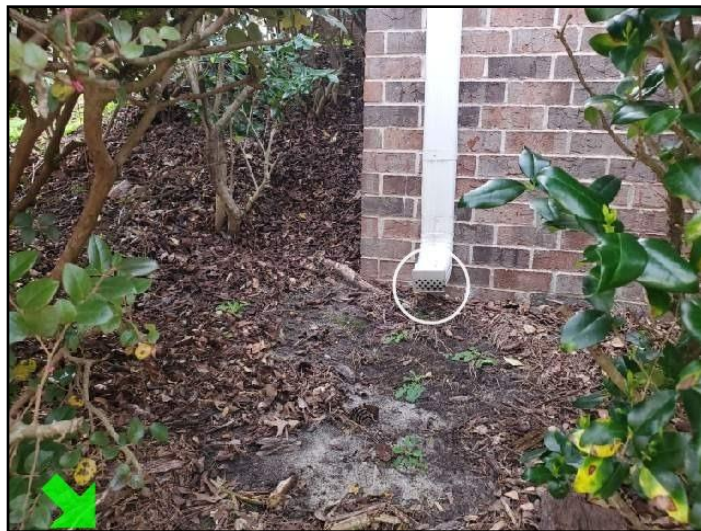
Screens help to keep critters out but also can encourage clogging. Extensions are recommended and if screens remain routine monitoring for clogging is recommended. This downspout is likely contributing to a wall crack at the porch.

13. Screen present (Recommend extension)

**Task:** Recommend correction

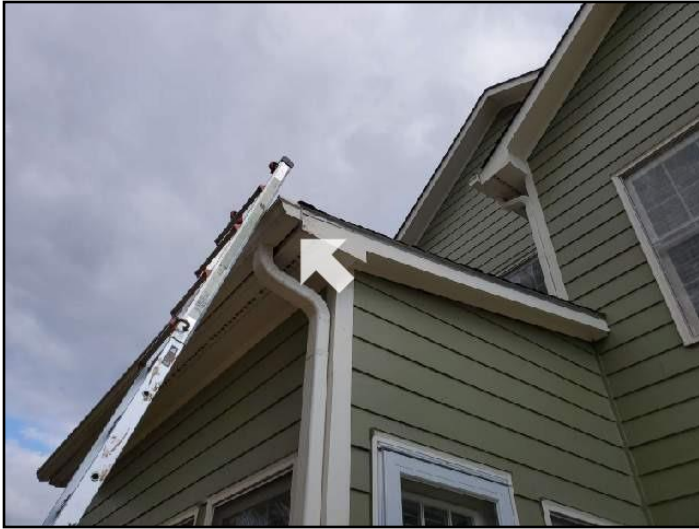
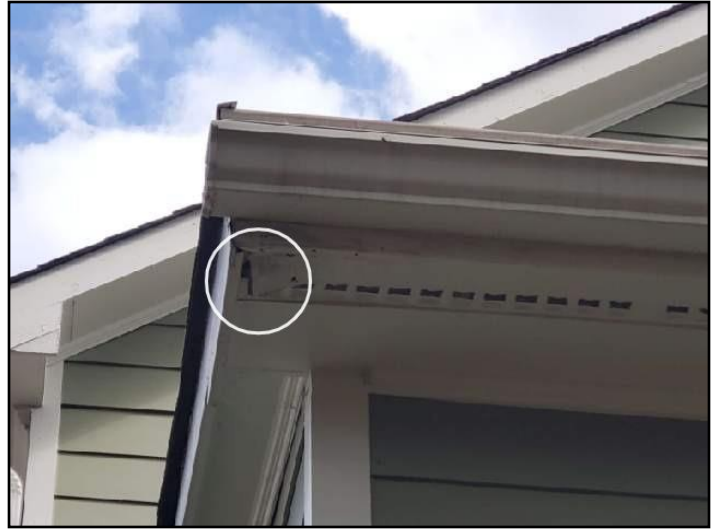
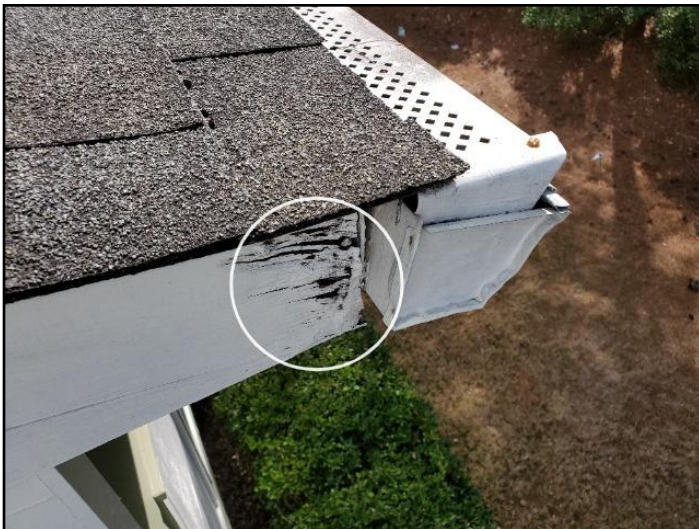
There are @ 10 areas where the wood trim is water damaged, which include several at the eaves, the garage door and at least one window at the rear.

14. Rot

15. Rot

16. Rot

**Task:** Recommend correction

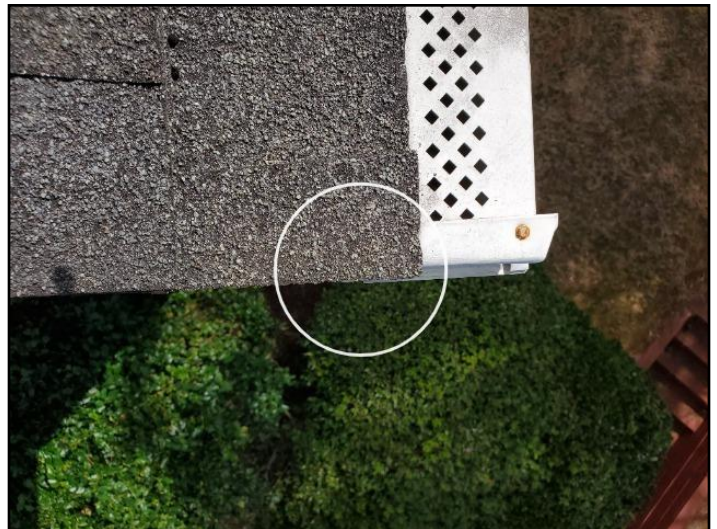
17. Shingles may need to be trimmed

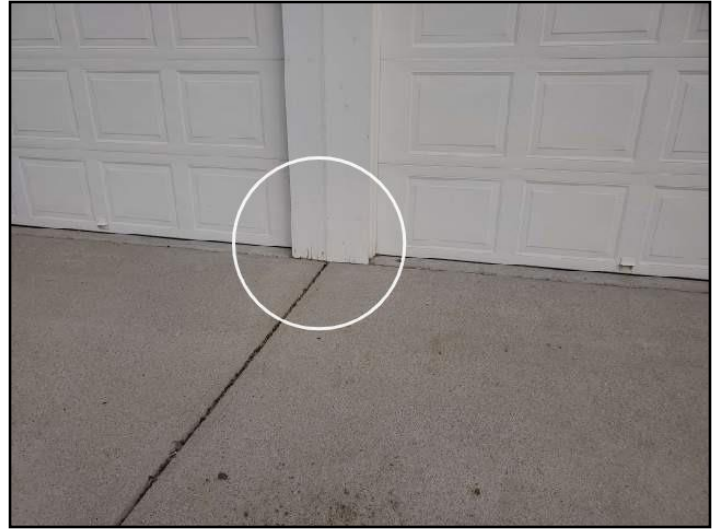
19. Rot @ garage door trim

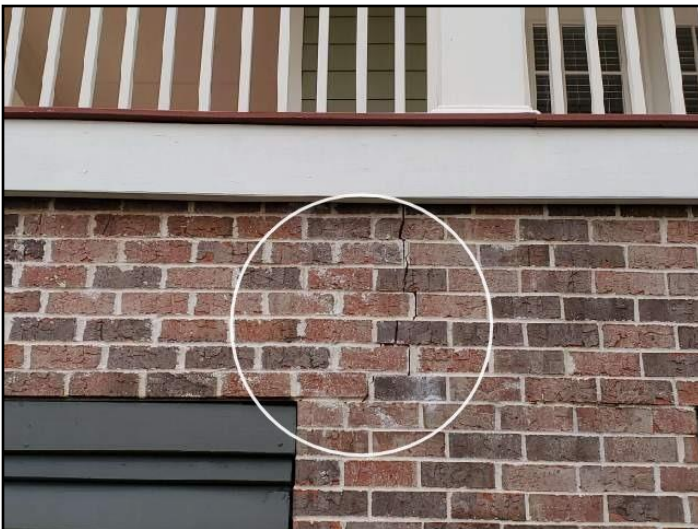
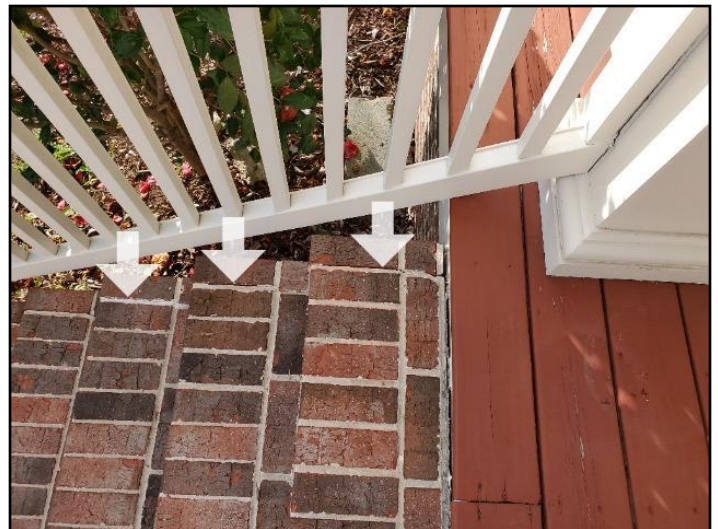
Sealing the brick at the porch and correcting the mortar deterioration at the steps is recommended. Correcting the downspouts will also help to avoid any further settling at the porch.

20. Cracked

21. Deteriorated Mortar (Not yet loose)

**Task:** Recommend a masonry contractor or qualified handyman

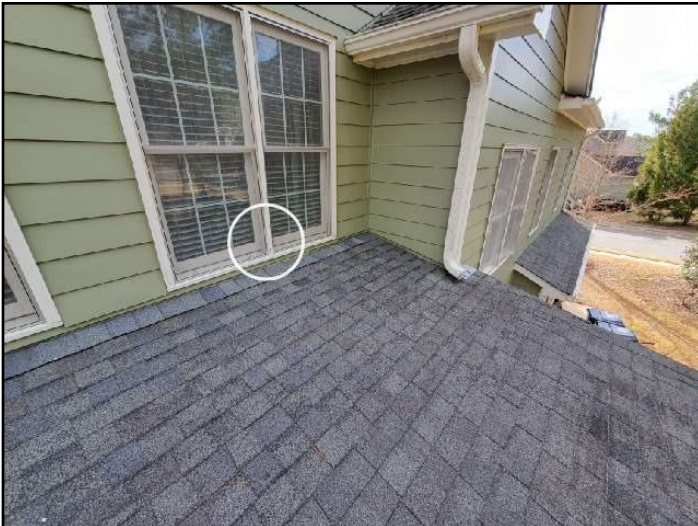
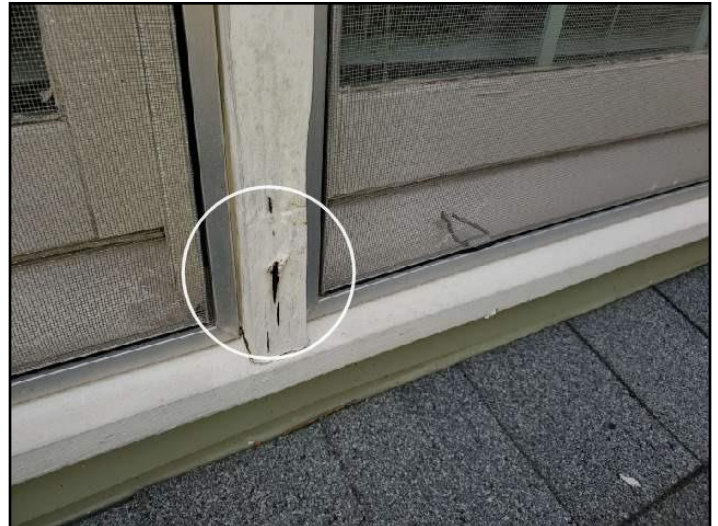
23. Rot

24. Rot

Task: Recommend a trim carpenter prior to paint

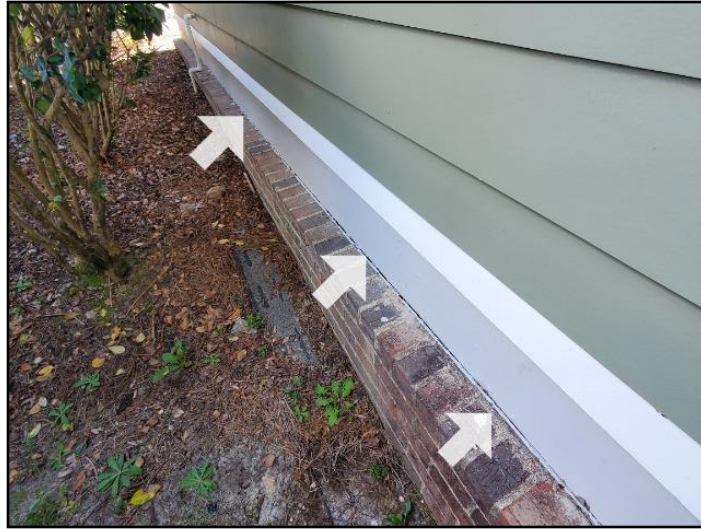
25. Caulking deteriorated

Task: Recommend correction

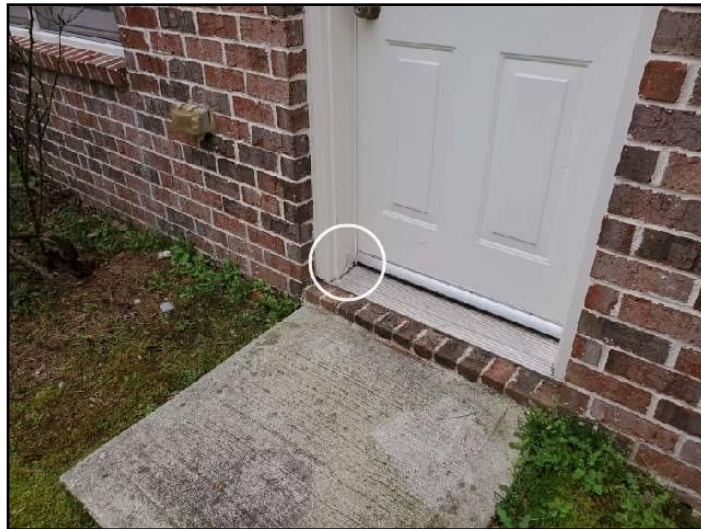
26. Rot

**Task:** Recommend a trim carpenter prior to paint

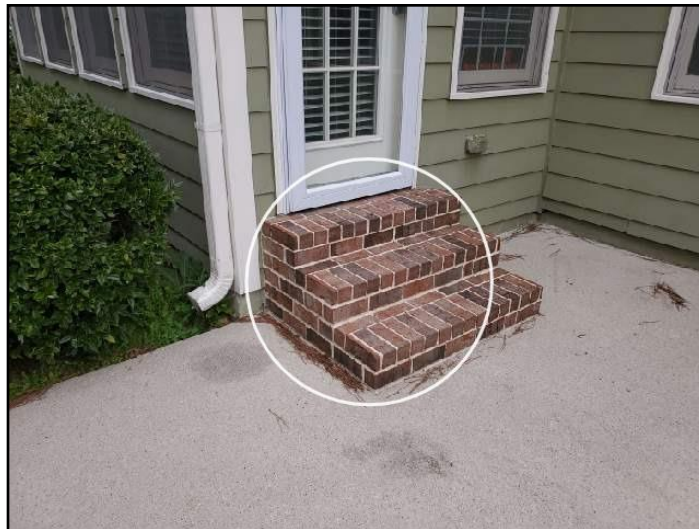
Handrails are recommended where there are 3 or more risers.

27. Missing

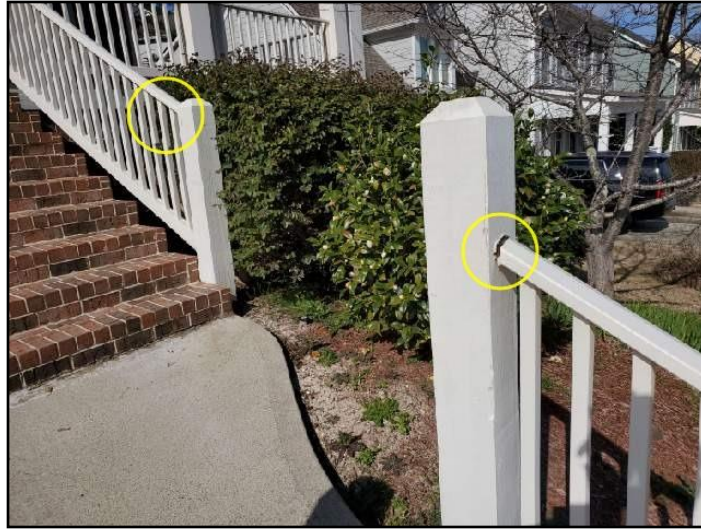
28. Loose

It's recommended to secure the handrails at two locations and paint.

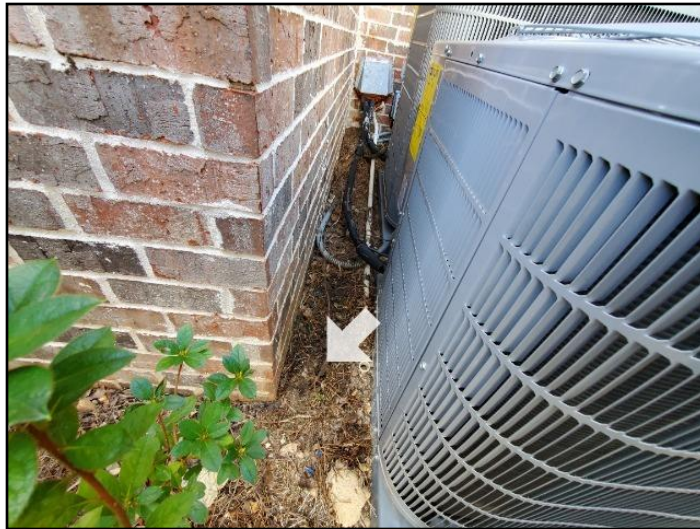
The ground conductor is visible but is buried. The ground type could not be determined. Also the hydro- massage tub ground is connected to plastic pipe at the master bedroom.

30. Not visible

**Task:** Recommend evaluation by a licensed electrician

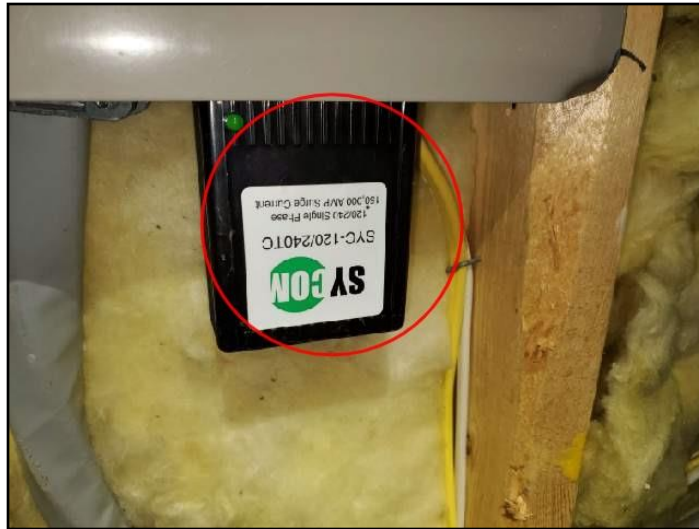
June 20, 2019 /PRNewswire/ -- The following is a reissue and expansion of UL public notice 16PN-10, previously released on July 29, 2016 for potentially hazardous surge protectors. UL has expanded the notice to include Sycom Model SYC-120/240-TC. This product does not comply with UL's Safety Standards and is not authorized to bear the UL Mark for the United States or Canada. This surge protector may pose a fire hazard.

UL is aware of several reports on <http://www.saferproducts.gov> that involve fires with these surge protectors. UL recommends that you stop using all models identified in this notice.

31. Recalled Surge Protector

**Task:** Recommend evaluation by a licensed electrician

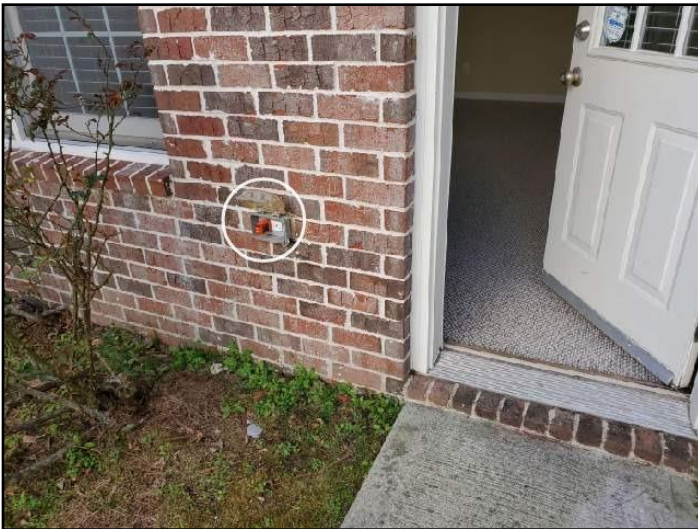
32. Test faulty on GFCI/GFI (Ground Fault...

Task: Recommend evaluation by a licensed electrician

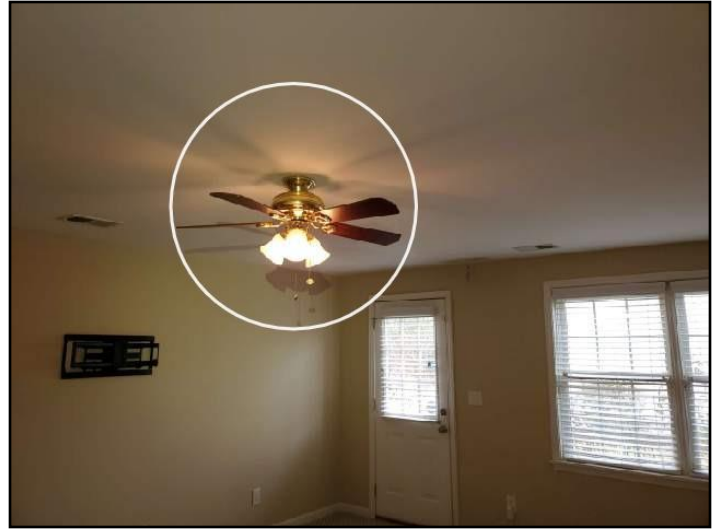
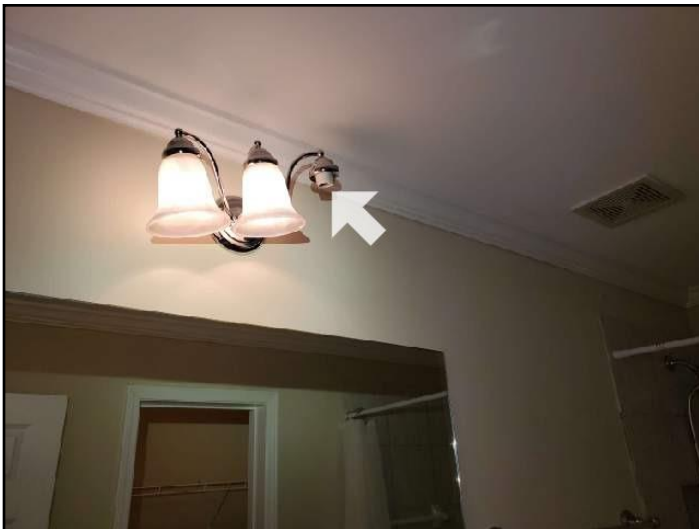
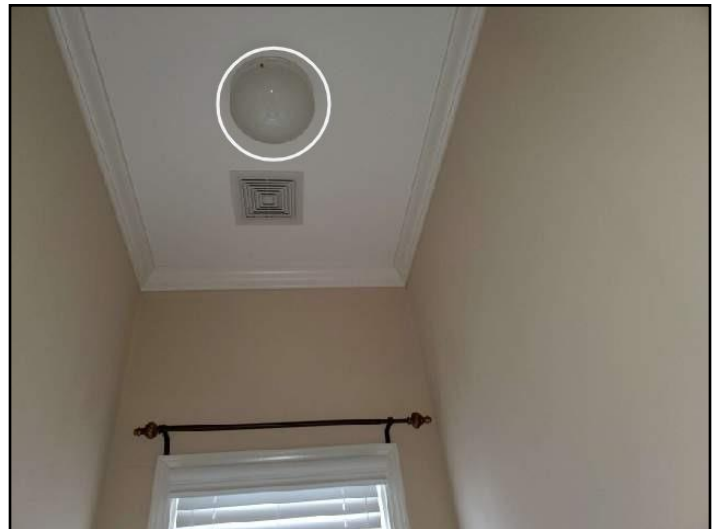
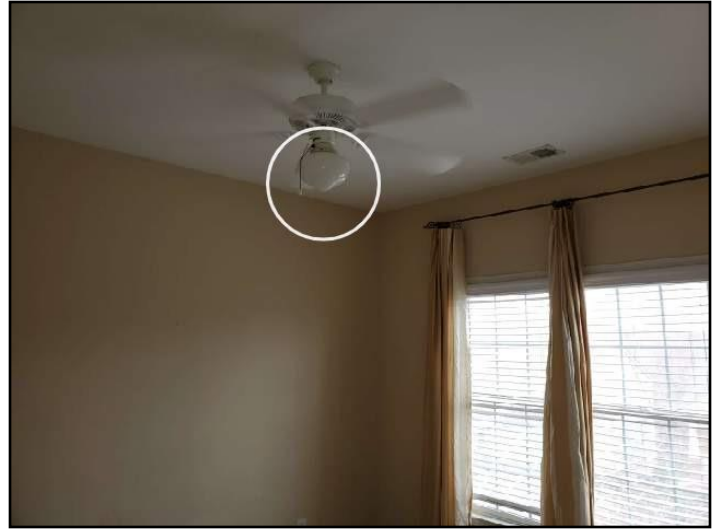
Several bulbs bad or missing and one ceiling fan in the basement was inoperable.

**39.** Fan Inoperative @ basement

**40.** Loose fixture and missing a bulb

**41.** Inoperative @ master bathroom

43. Inoperative

Task: Recommend correction

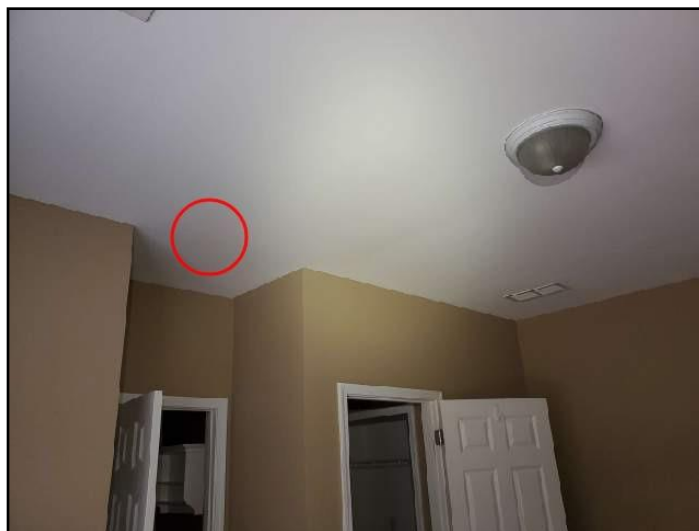
Smoke detectors were not installed at all locations that would meet today's safety standards. Carbon Monoxide detectors are also recommended. Smoke detectors are now required in common areas on each level as are Carbon Monoxide detectors. There are Smoke/CO combo units that can serve these areas. Smoke detectors are also recommended in all inhabitable rooms which are considered rooms where one may sleep or nap.

44. Missing @ bedrooms

**Task:** Recommend correction

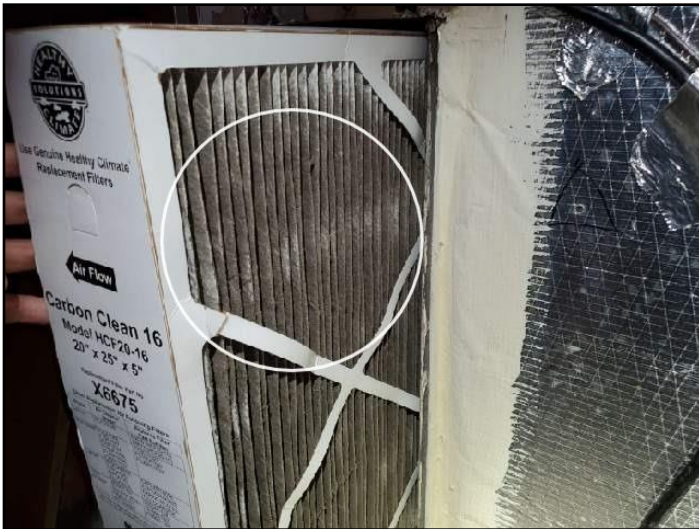
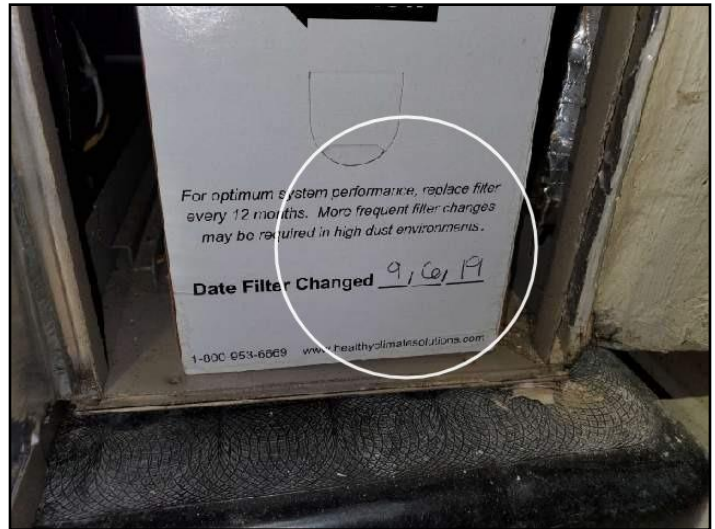
This filter type is recommended to be replaced every 6-12 months.

50. Dirty

51. Last replacement 2019

**Task:** Recommend filter replacement no more than every 12 months.

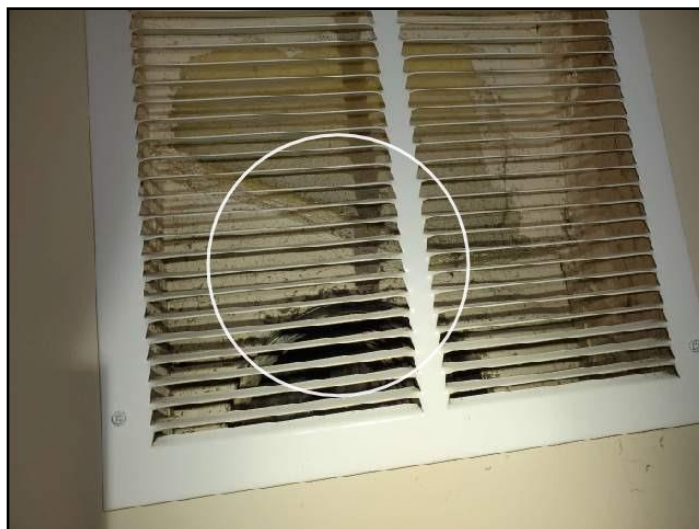
52. Dirty

**Task:** Recommend a duct cleaning contractor

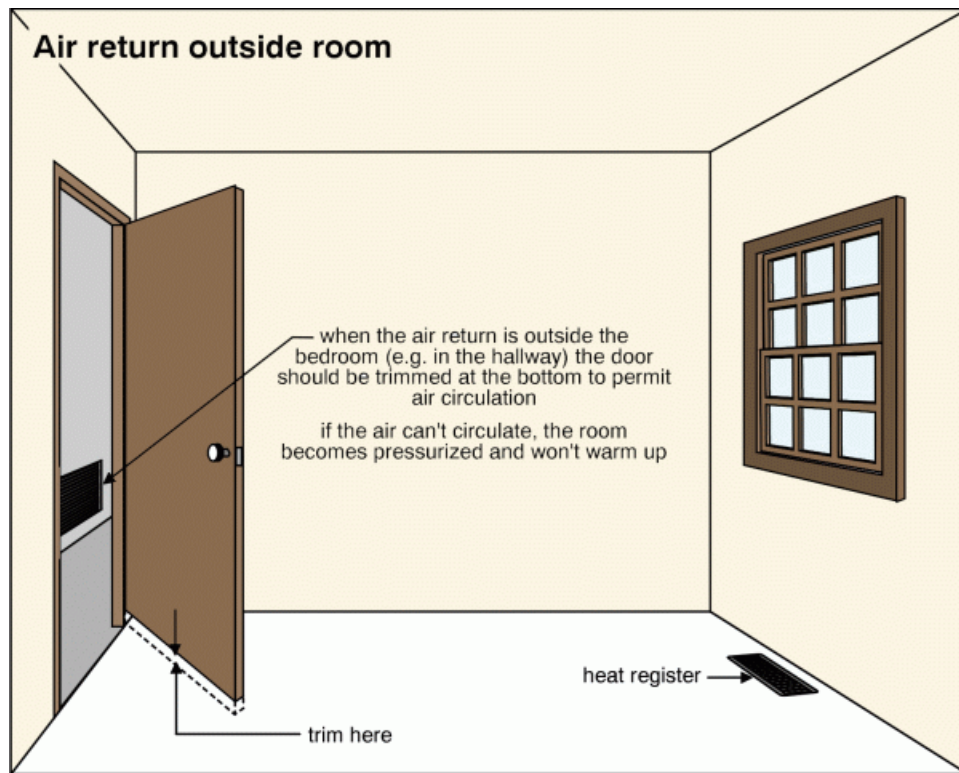
No return in sunroom can cause pressure imbalances if the door is shut and the system is running. Similarly in the 1st floor bathroom where stripping is installed at the bottom of the doors. The implications are positive pressures in the room which can lead to heat loss and/or the inability for the room to heat.

53. Poor location

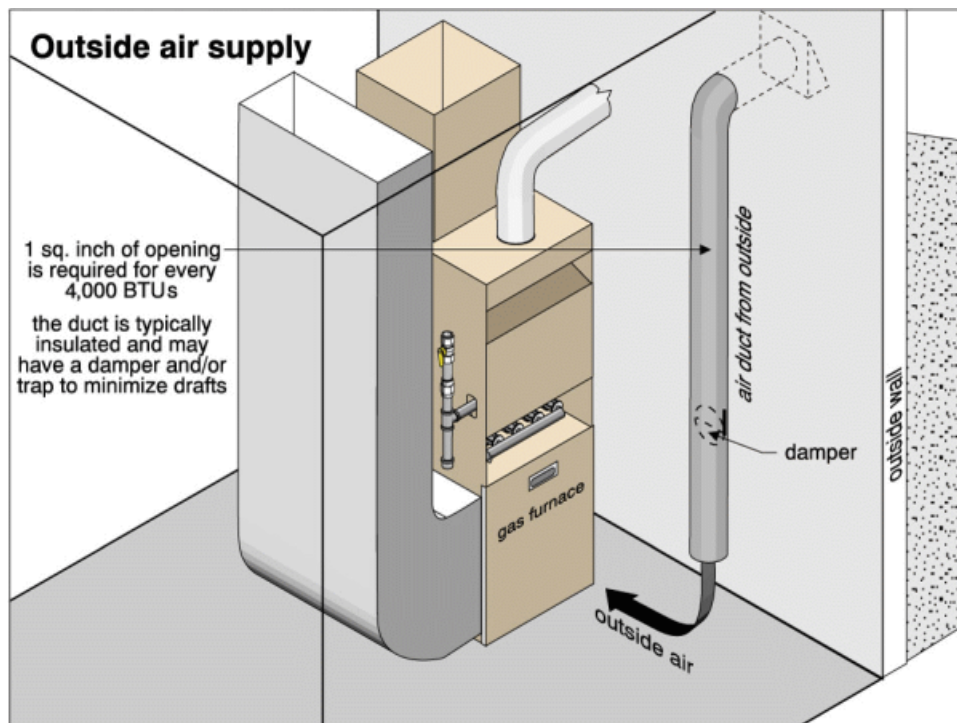
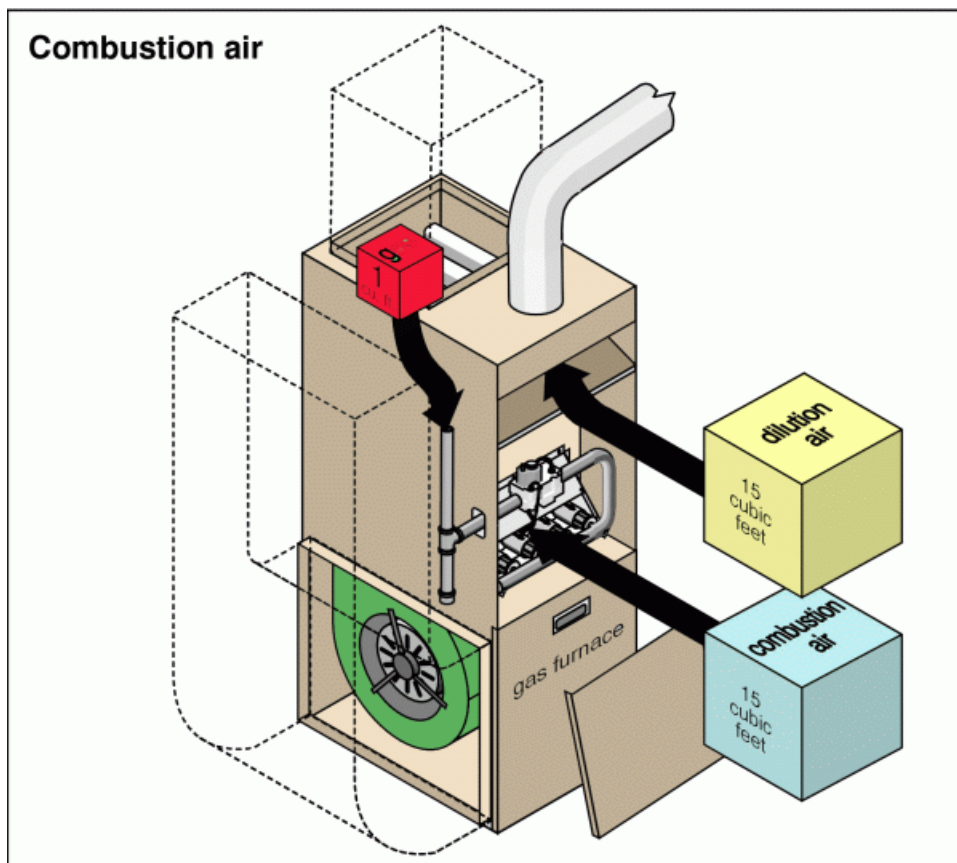
126k btu gas appliances are installed in the basement. The vents for the combustionair source has been modified and one vent removed and sealed. This may result in inadequate combustion air supply for the two gas appliances and could result in oxygen depletion in the space.

**Task:** Recommend evaluation by a licensed hvac contractor

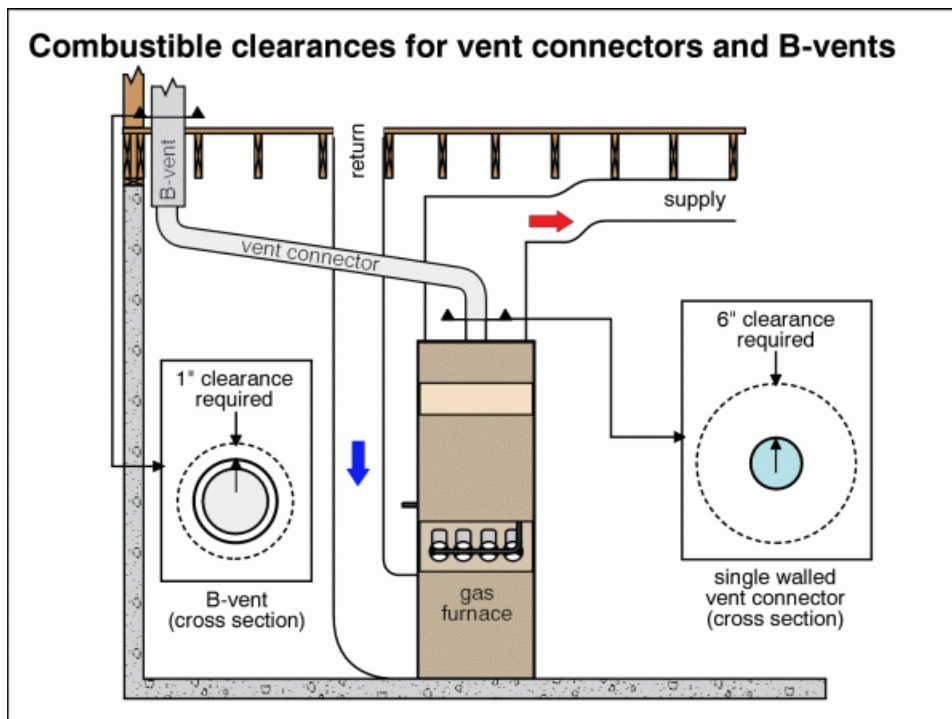
26. Condition: • [Combustible clearance](#)

Task: Recommend evaluation by a licensed hvac contractor

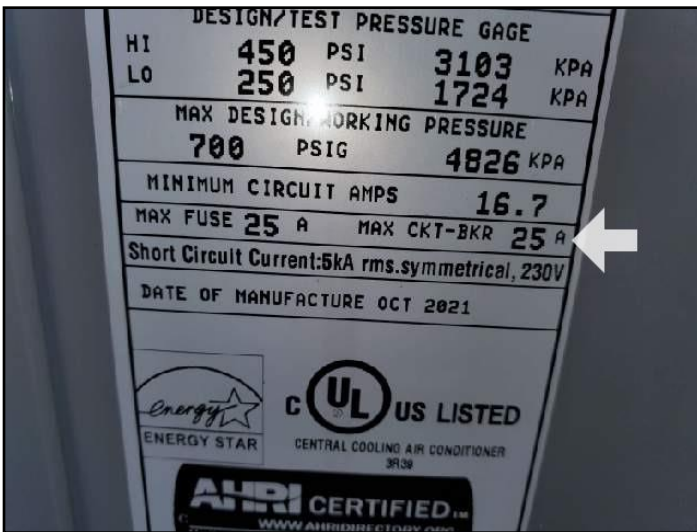
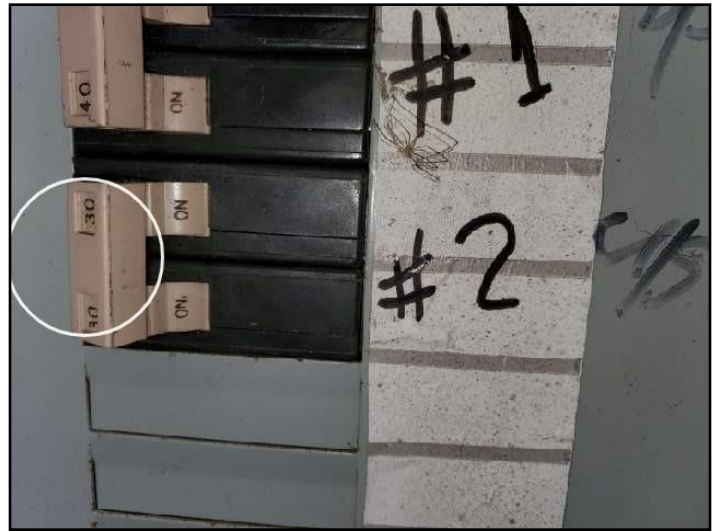
The newer 2.5 Ton Carrier unit has a 30 Amp breaker installed and Carrier recommends no larger than 25A. CH Type (Tan) breaker. Wire gauge is ample and correct.

65. Wrong fuse or breaker size

66. Wrong fuse or breaker size

**Task:** Recommend evaluation by a licensed electrician

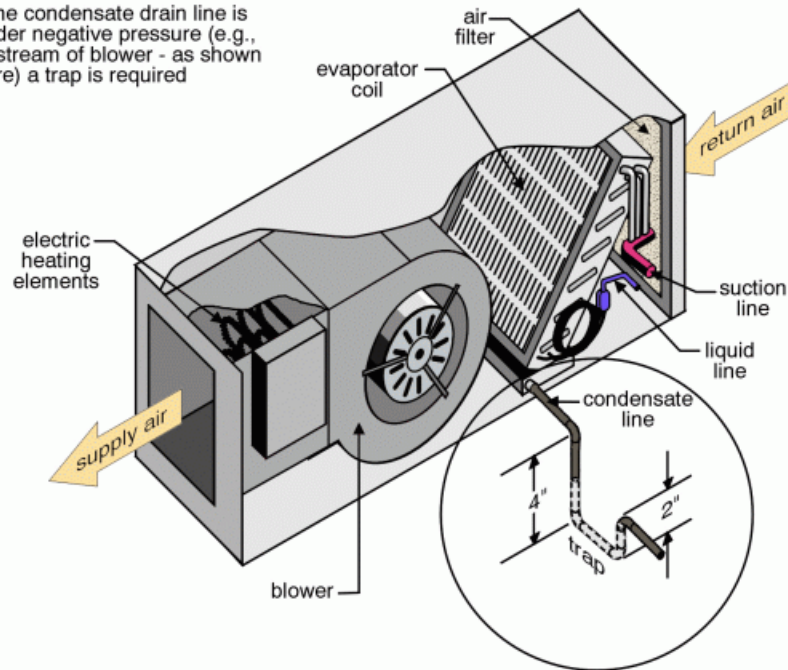
if the condensate drain line is under negative pressure (e.g., upstream of blower - as shown here) a trap is required

67. No trap

**Task:** Recommend evaluation by a licensed hvac contractor

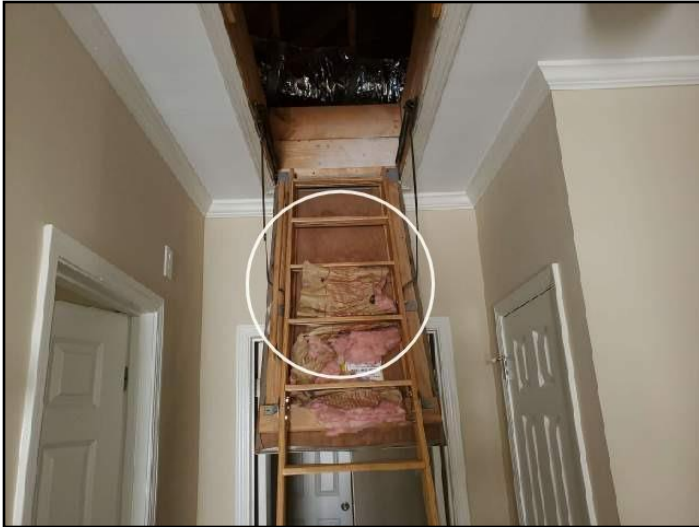
Overall the insulation amount was to current standards through there was some sections not uniform in amount and the pull down attic access insulation was insufficient. Rigid foam board will provide some R-Value but a

69. Gaps or voids

**Task:** Recommend correction

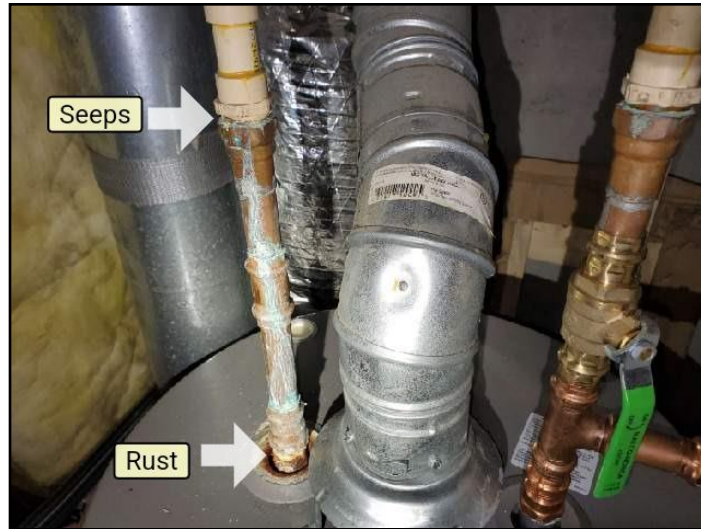
Seepage at a supply connection between the CVPC and COpper at the gas water heater is causing rust at the 3 year old water heater.

72. Leak

**Task:** Recommend evaluation by a licensed plumber

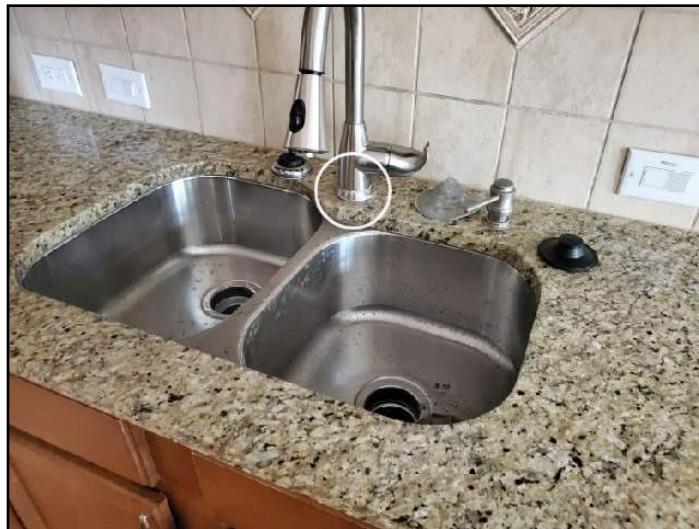
73. Loose

**Task:** Recommend correction

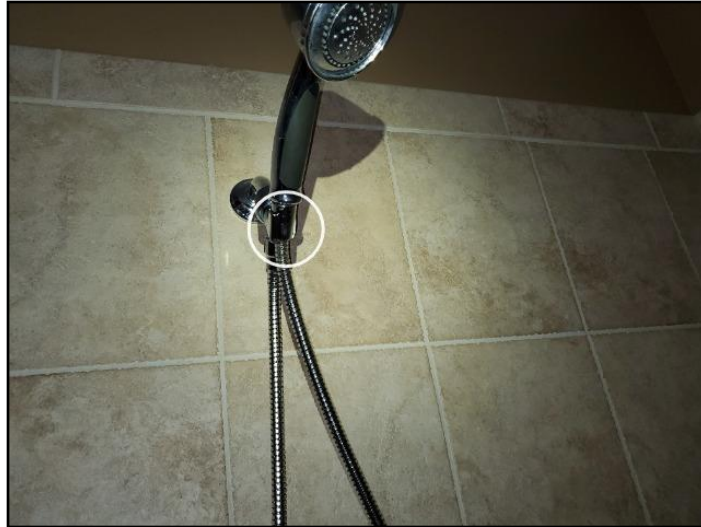
*74. Shower head damaged*

**Task:** Recommend correction
