# Your Inspection Report

2014 Lola Lane  
Ludoville, GA 30114

**INSPECTION DATE:**  
Sunday, March 6, 2022

**PREPARED BY:**  
Glen Williams

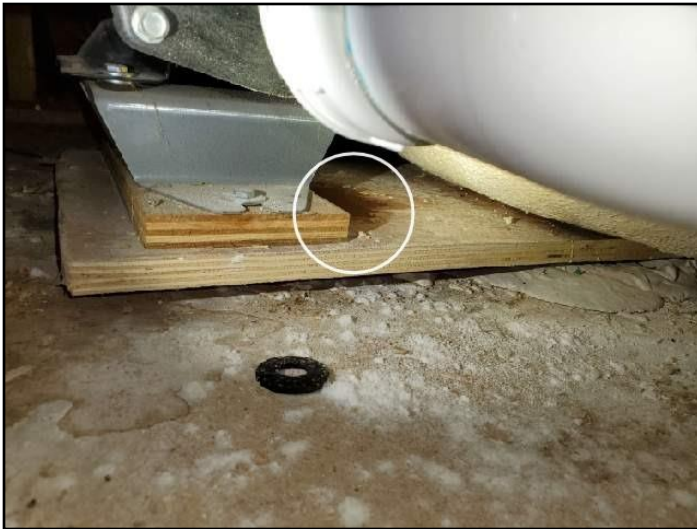
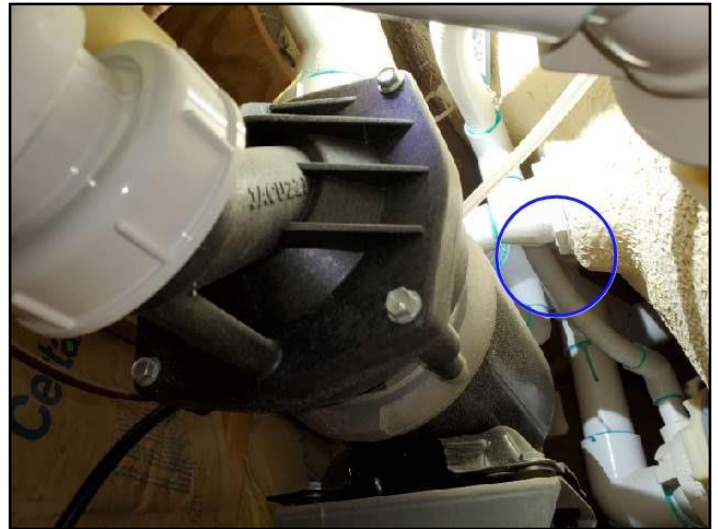
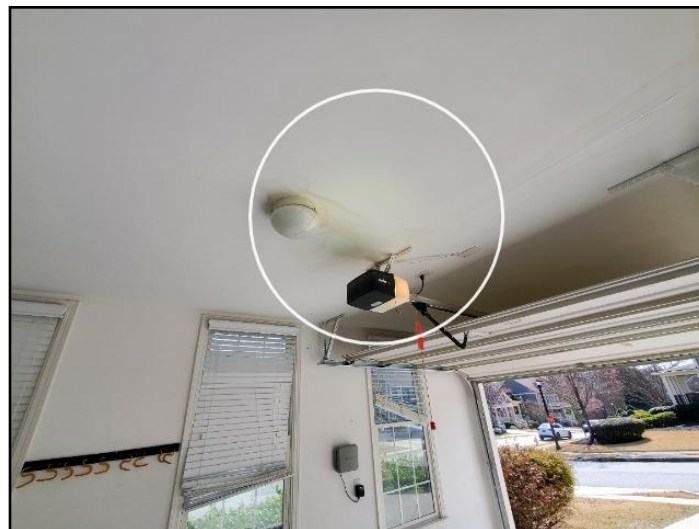
Leak at the hydro-massage tub appears to be coming from a connection at the drain or a jet. It has caused stains at the garage ceiling. Recommend a plumber for correcting the leak and a drywall contractor for cosmetic repairs.

75. Leak

76. Leak

77. Stains @ garage in 2 locations

**Task:** Recommend evaluation by a licensed plumber

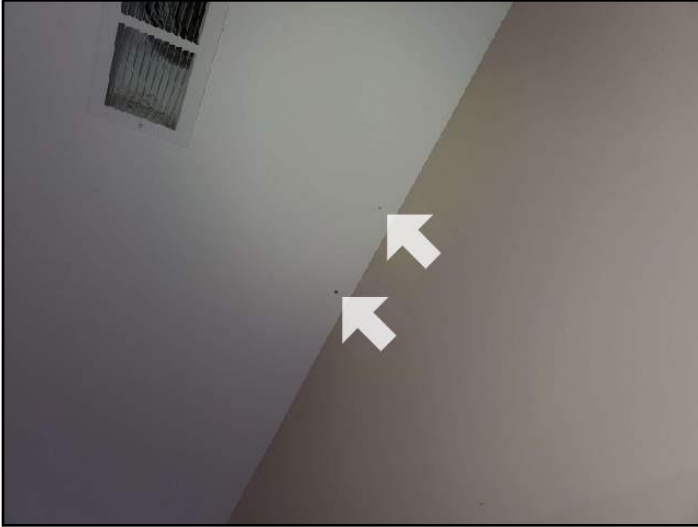
Peeling tape joints such as this is common and usually related to humidity in the home especially at high ceilings where humidity is highest. This is mostly caused by lack of use of the cooling system, long extended times of no hvac usage such as vacancy or poor filter changing habits. Its more prominent in bedrooms bathrooms attached.

87. Nail pops

**Task:** Correct for cosmetic sake.

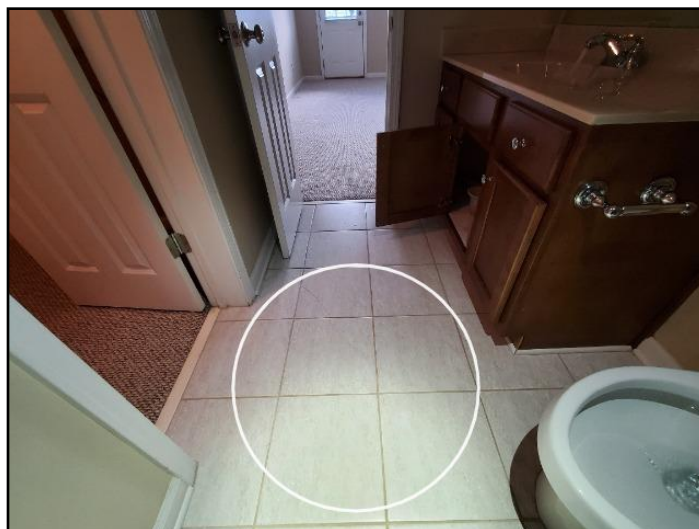
89. Tiles cracked

**Task:** Recommend a tiles contractor for correction

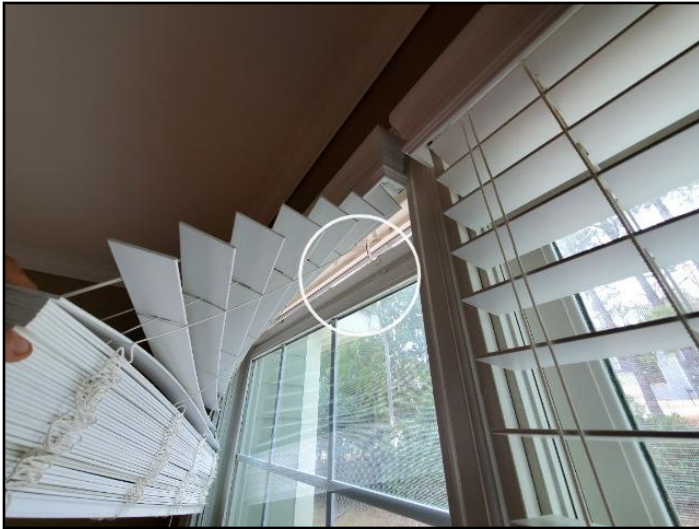
Overall the windows were in good condition and operable but some of the top sashes were dropping when the windows were unlatched. This can primarily be a security issue but can also allow heat loss and bring unnecessary humidity into the home.

90. Top sash

**Task:** Recommend a window contractor for evaluation

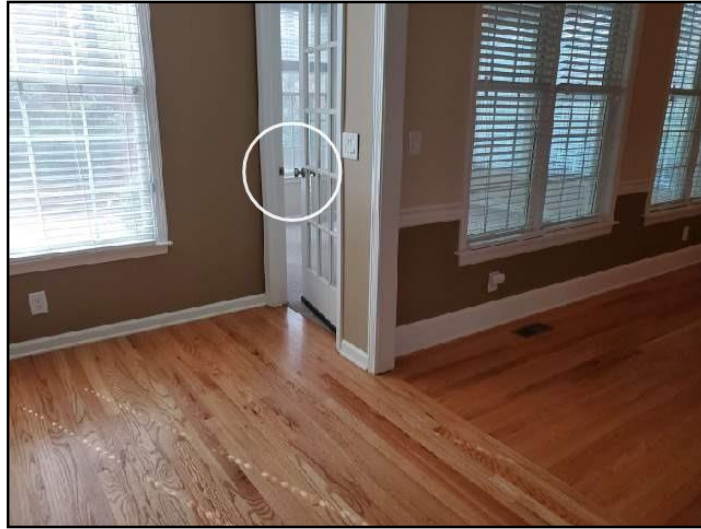
96. Latch not effective on exterior door

Task: Recommend correction

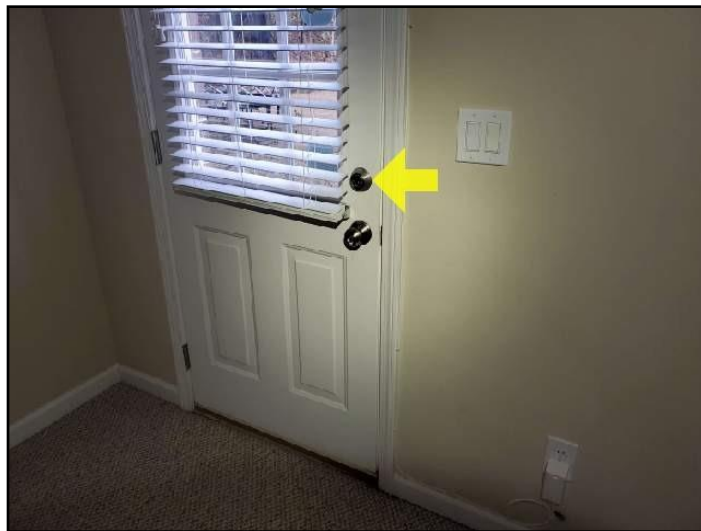
97. Keyed at interior

**Task:** Recommend correction

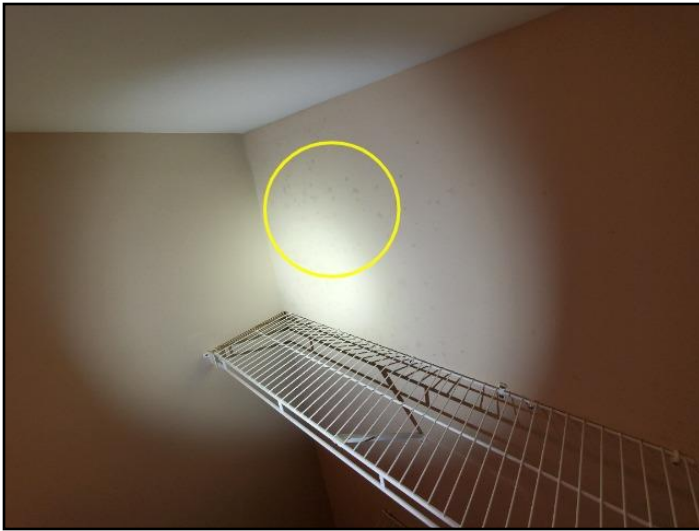
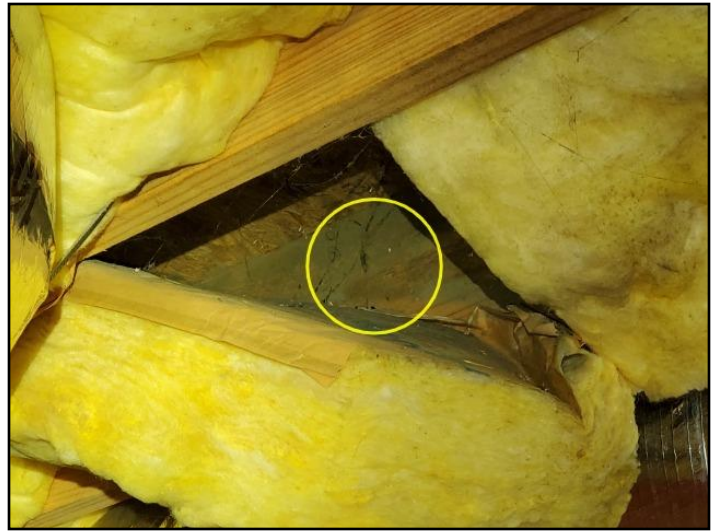
Some fungal like growth was present at some areas of the wood framing in the basement and the drywall in the basement bathroom closet. Cleaning the substance with proper PPE is recommended. For professional evaluation an environmental contractor is recommended.

102. Fungal like Growth

103. Fungal like Growth

**Task:** Recommend cleaning

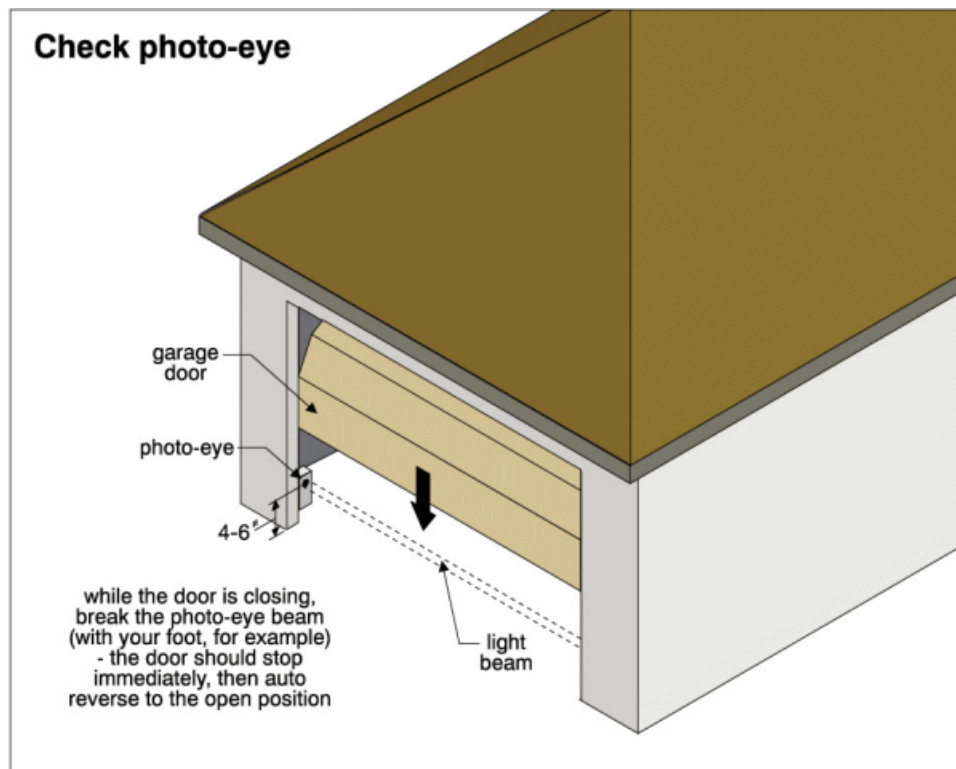
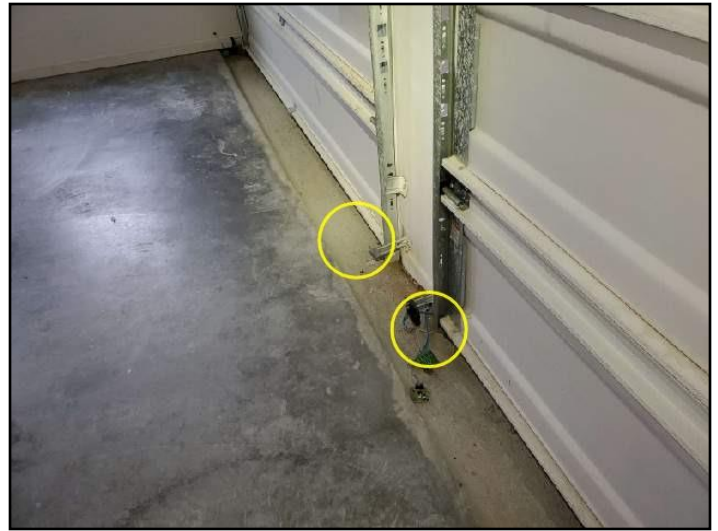
Sensors damaged and missing and buttons must be held down until doors are fully closed.

104. Sensors inoperative

105. Sensors inoperative

**Task:** Recommend a garage door contractor for correction

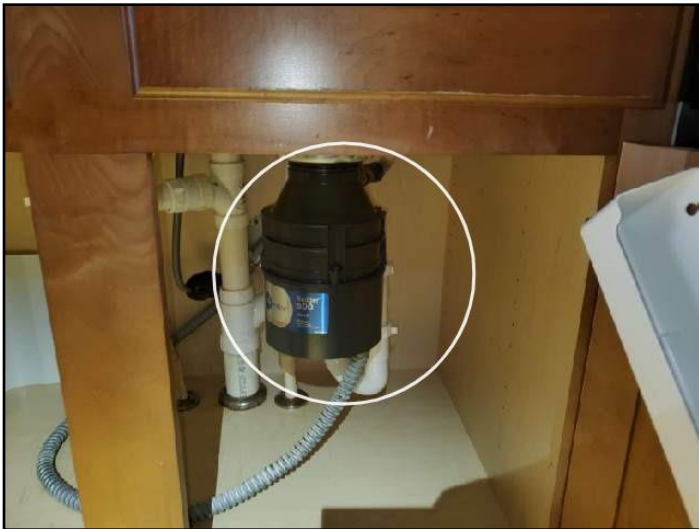
106. Inoperative

Task: Recommend evaluation by a licensed plumber
