# Your Inspection Report

2014 Lola Lane  
Ludoville, GA 30114

**INSPECTION DATE:**  
Sunday, March 6, 2022

**PREPARED BY:**  
Glen Williams

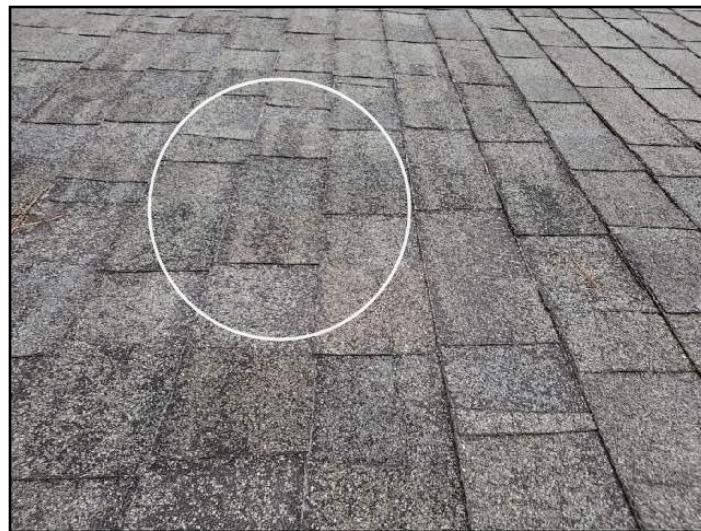
5. Granule loss

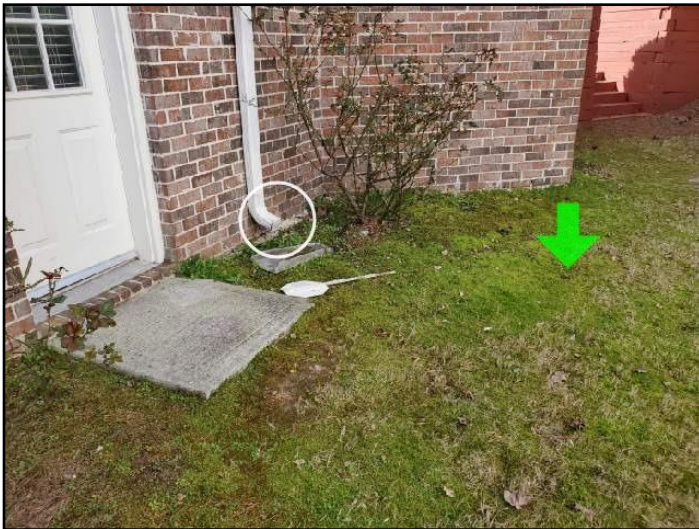
10. Discharge too close to building

It's recommended to correct all downspouts that are discharging too close to the home with extensions.

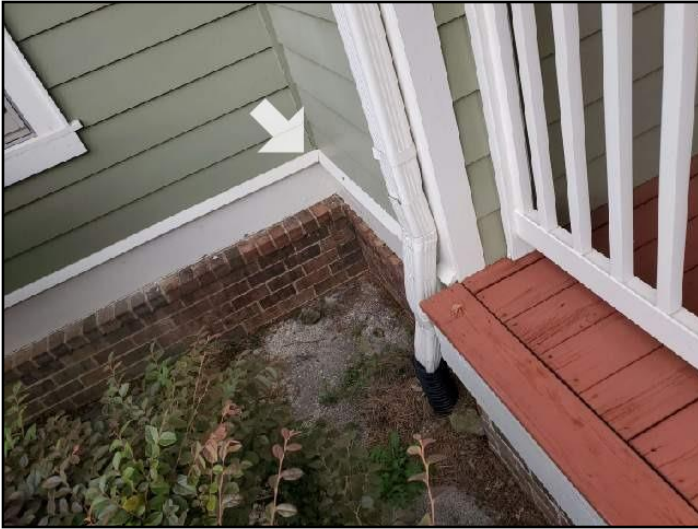
There are @ 10 areas where the wood trim is water damaged, which include several at the eaves, the garage door and at least one window at the rear.

18. Soft wood trim

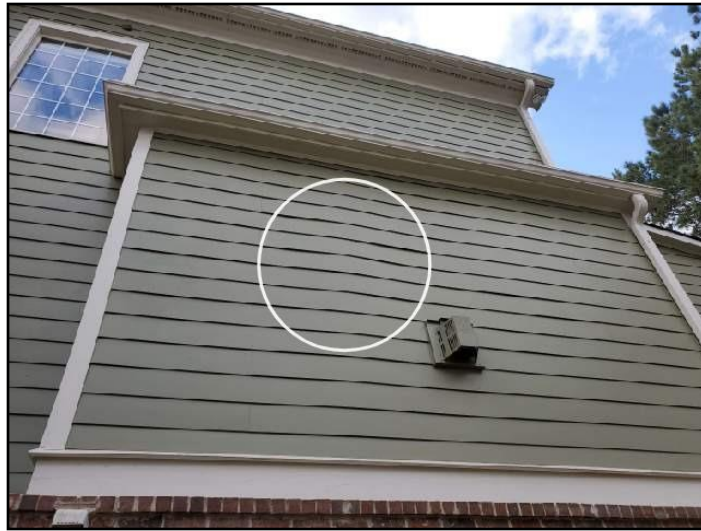
22. Buckled

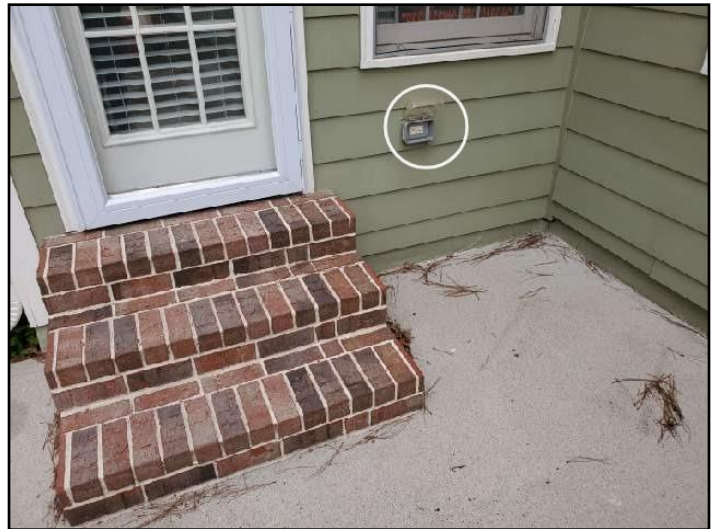
33. Test faulty on GFCI/GFI (Ground Fault...

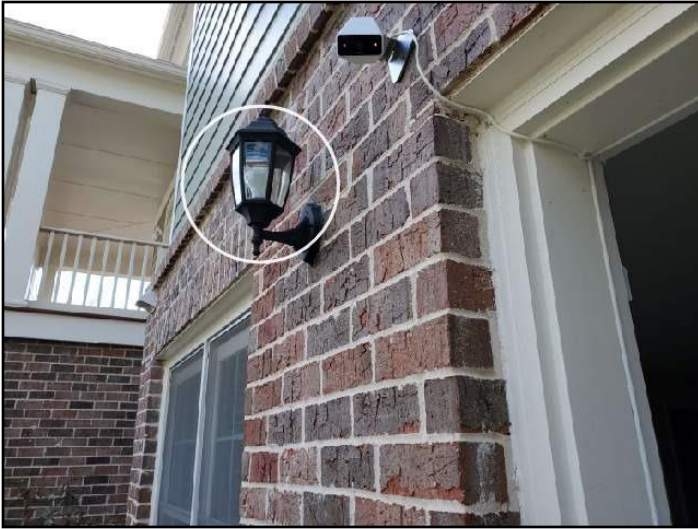
34. Inoperative

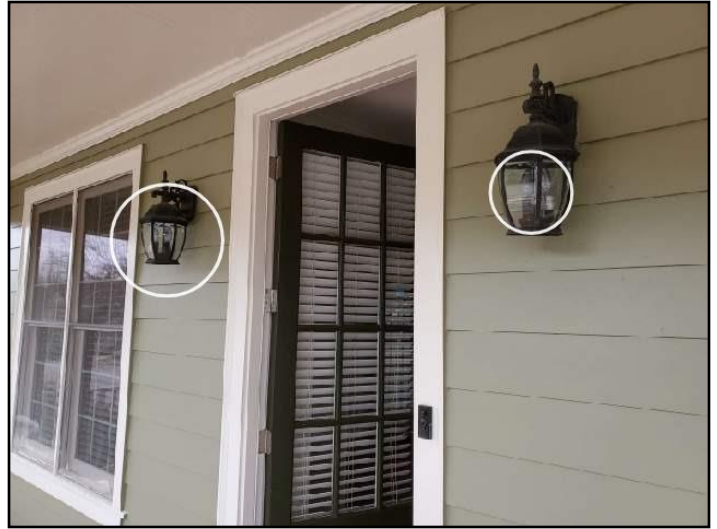
35. 3 of 6 Inoperative

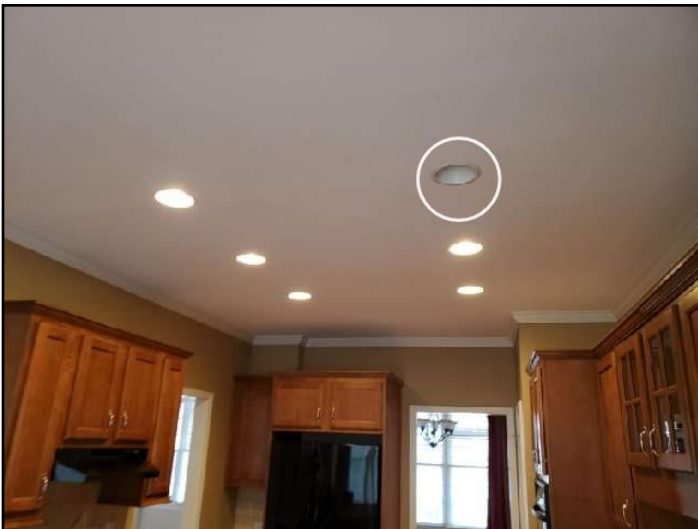
36. Inoperative

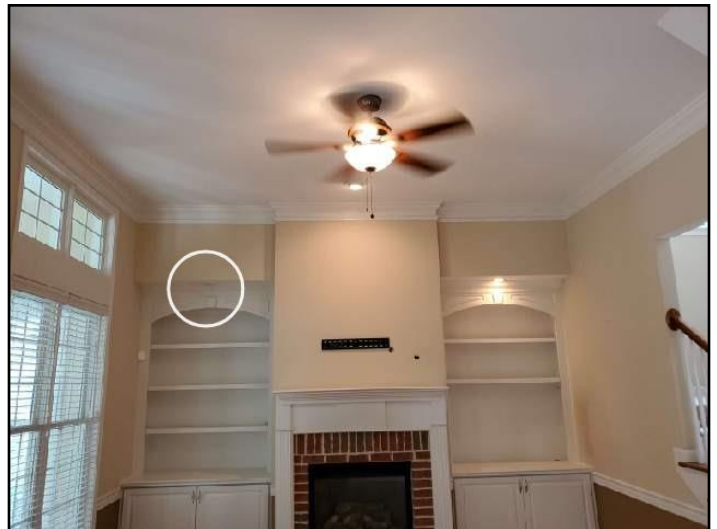
37. Inoperative

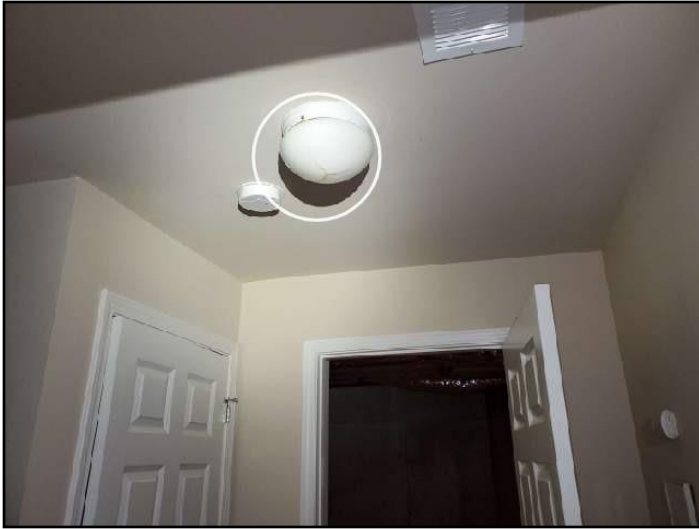
**38.** Inoperative @ basement

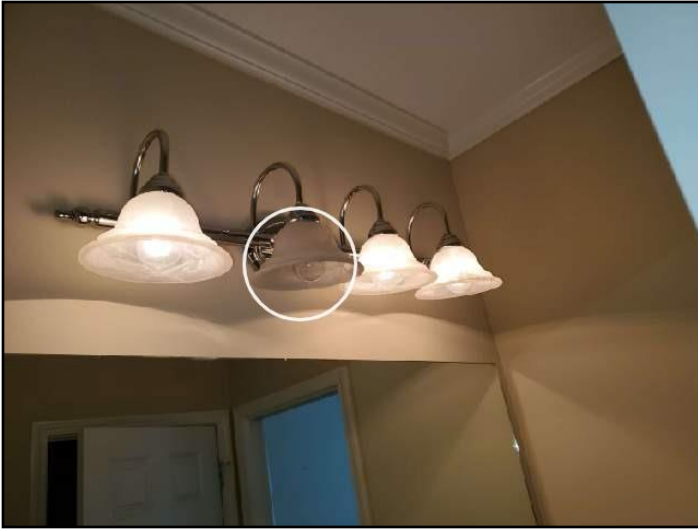
42. Inoperative

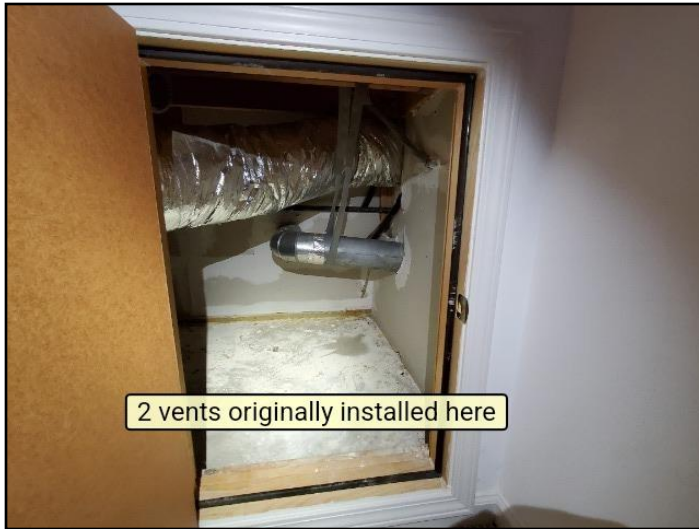
54. The original outside air vents modified

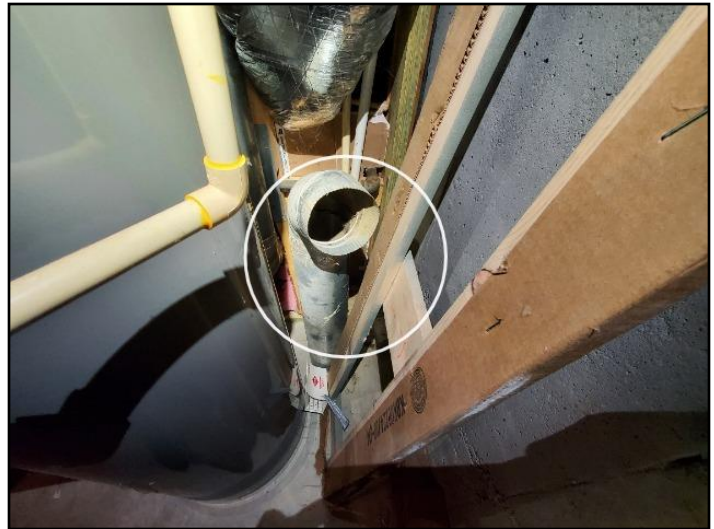
55. One vent removed and sealed off

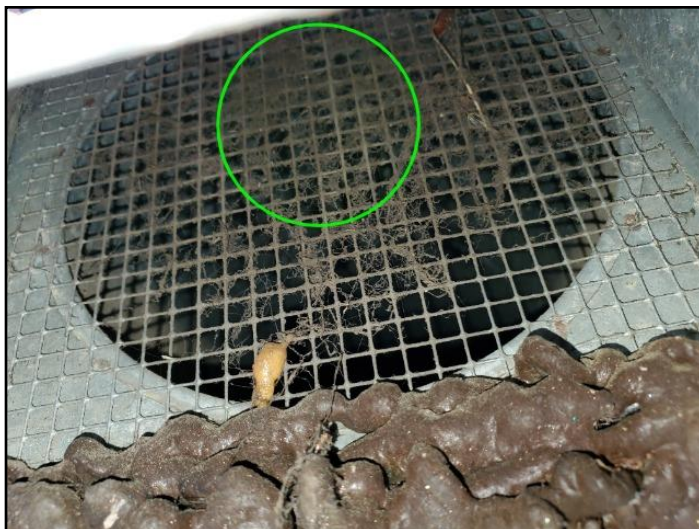
56. Only 1 vent active

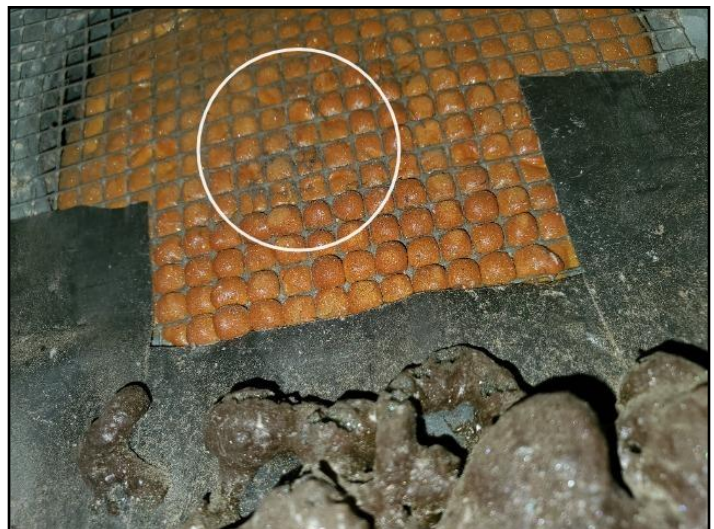
57. One vent sealed off

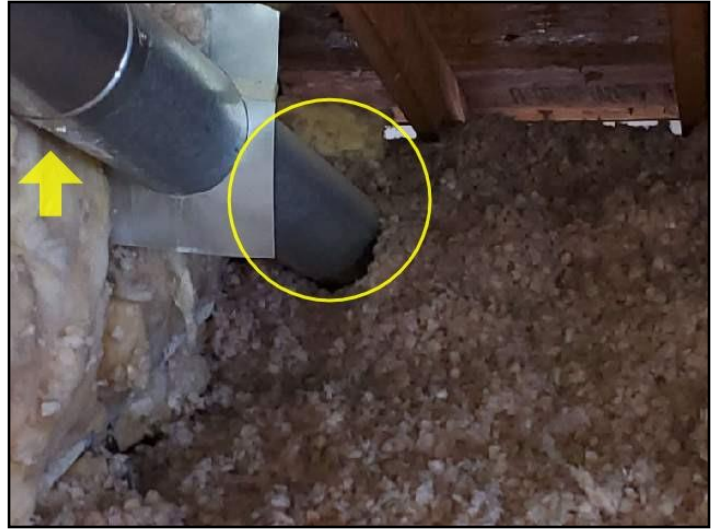
60. Combustible clearance @ Attic

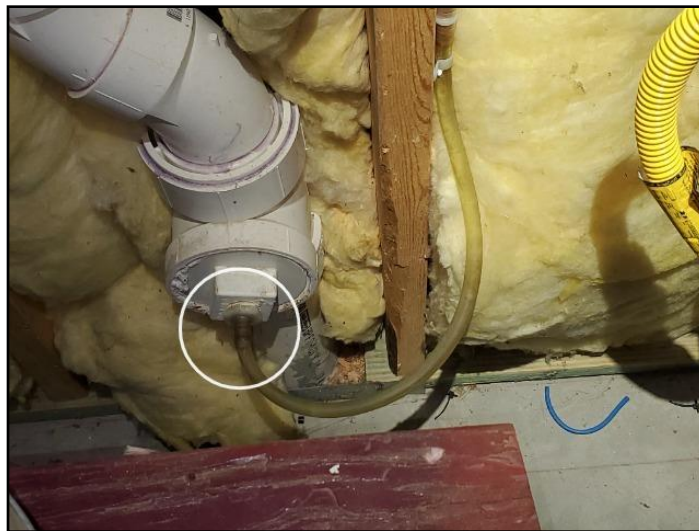
if the condensate drain line is under negative pressure (e.g., upstream of blower - as shown here) a trap is required

67. No trap

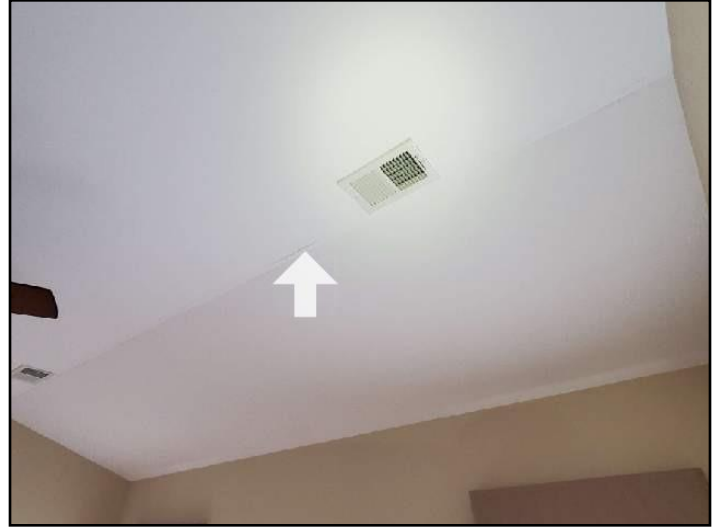
#### 35. Condition: • [Poor joints](#)

Peeling tape joints such as this is common and usually related to humidity in the home especially at high ceilings where humidity is highest. This is mostly caused by lack of use of the cooling system, long extended times of no hvac usage such as vacancy or poor filter changing habits. Its more prominent in bedrooms bathrooms attached.

88. Poor joints

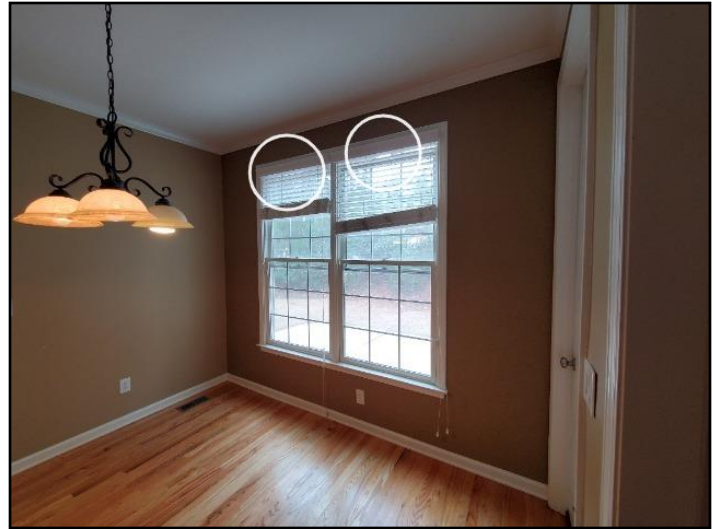
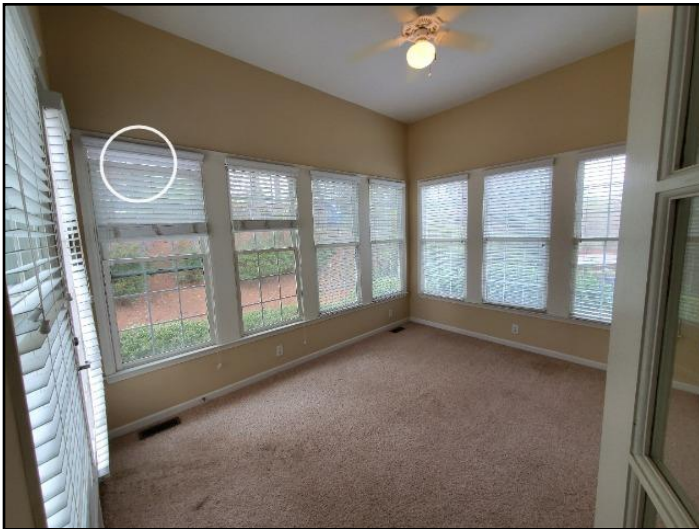
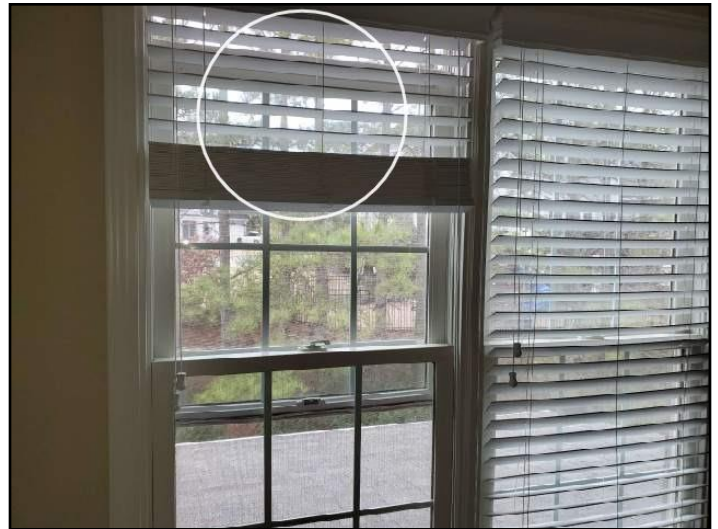
### 37. Condition: • Top sash

Overall the windows were in good condition and operable but some of the top sashes were dropping when the windows were unlatched. This can primarily be a security issue but can also allow heat loss and bring unnecessary humidity into the home.

91. Top sash

92. Top sash

93. Top sash

**Task:** Recommend a window contractor for evaluation

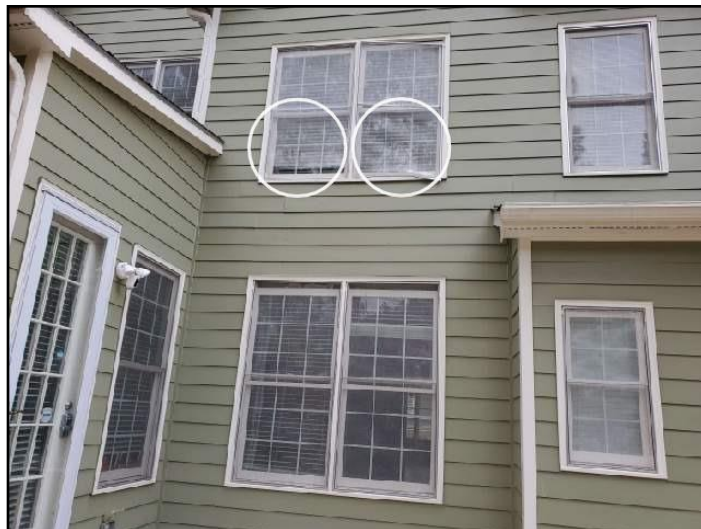
38. Condition: • [Torn](#)

@ 6 screens effected

95. Torn

Task: Consider correcting

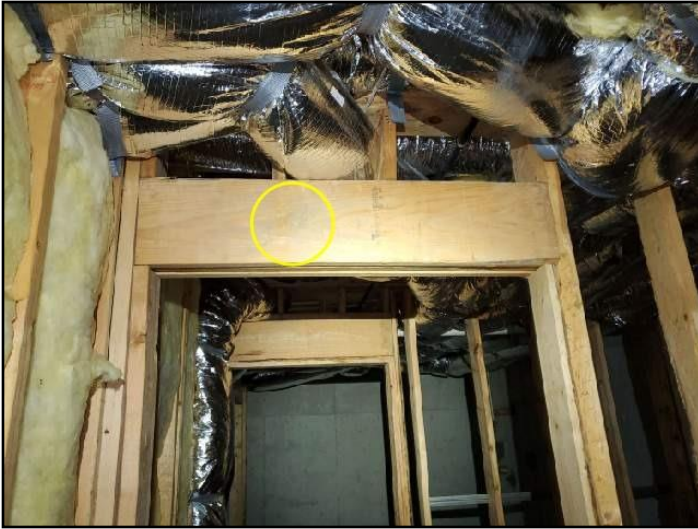
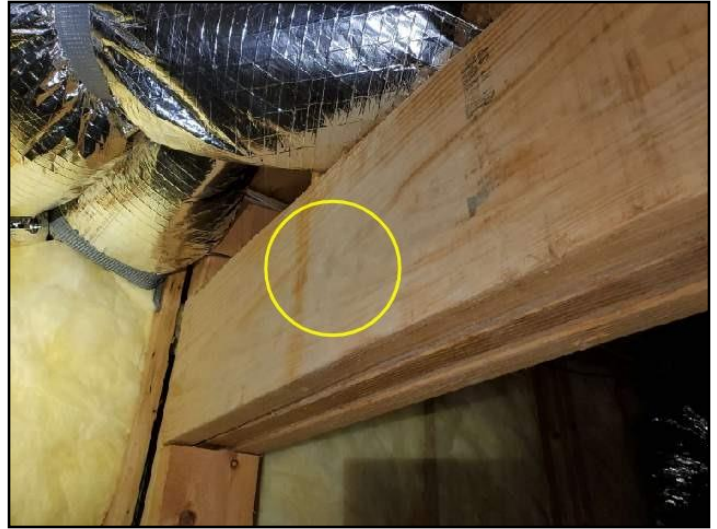
**41. Condition:** • Fungal like Growth

Some fungal like growth was present at some areas of the wood framing in the basement and the drywall in the basement bathroom closet. Cleaning the substance with proper PPE is recommended. For professional evaluation an environmental contractor is recommended.

98. Fungal like Growth

99. Fungal like Growth

**Task:** Recommend cleaning

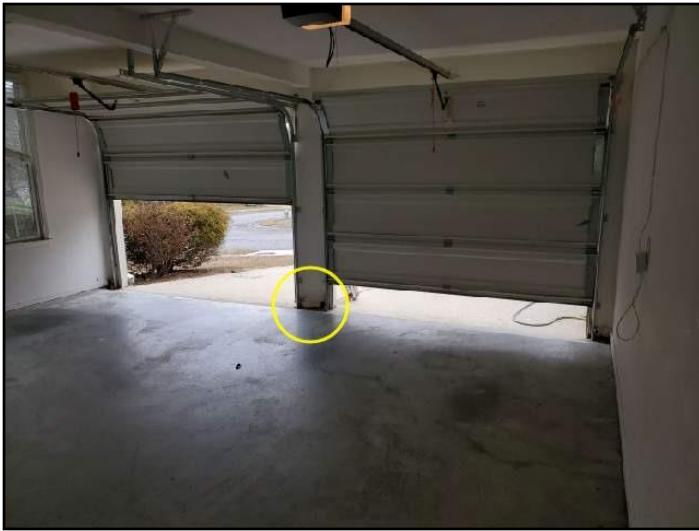
**42. Condition:** • Sensors inoperative

Sensors damaged and missing and buttons must be held down until doors are fully closed.

104. Sensors inoperative

**Task:** Recommend a garage door contractor for correction

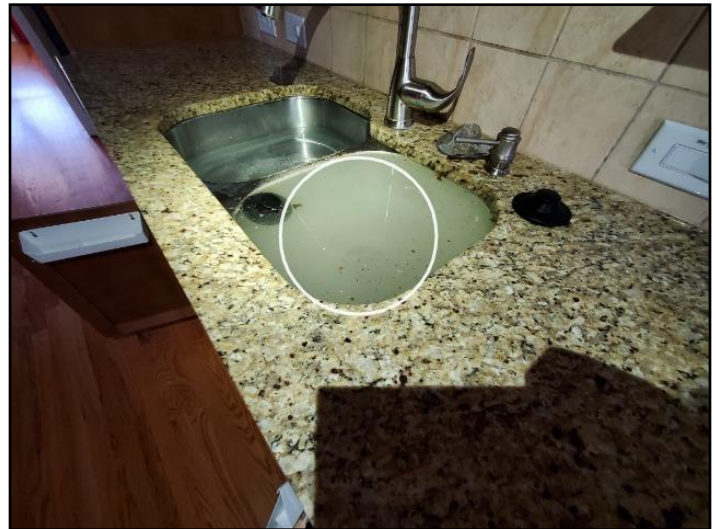
43. Condition: • Inoperative

107. Inoperative

Task: Recommend evaluation by a licensed plumber

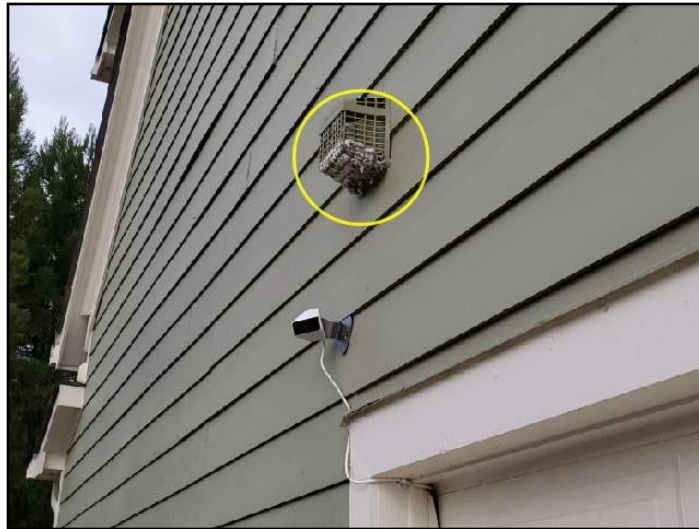
44. Condition: • Screen on vent termination

Recommend cleaning the lint and ensuring the vent is free and clear.

108. Screen on vent termination

Task: Recommend correction

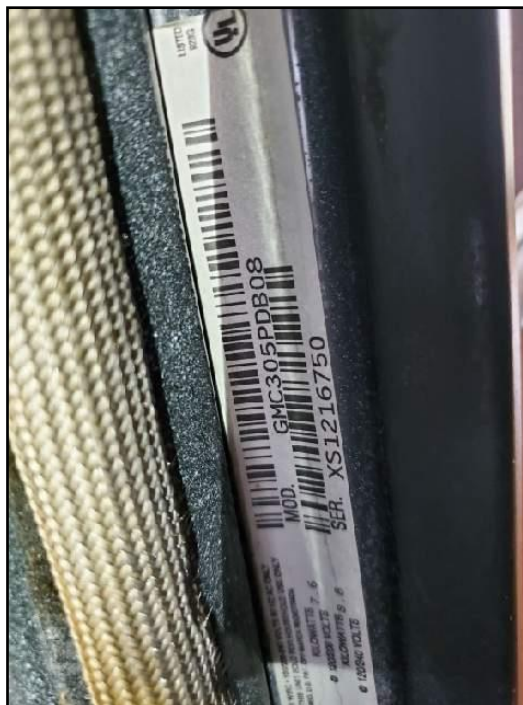
Wall Oven / Microwave combo - Operates

137. Whirlpool

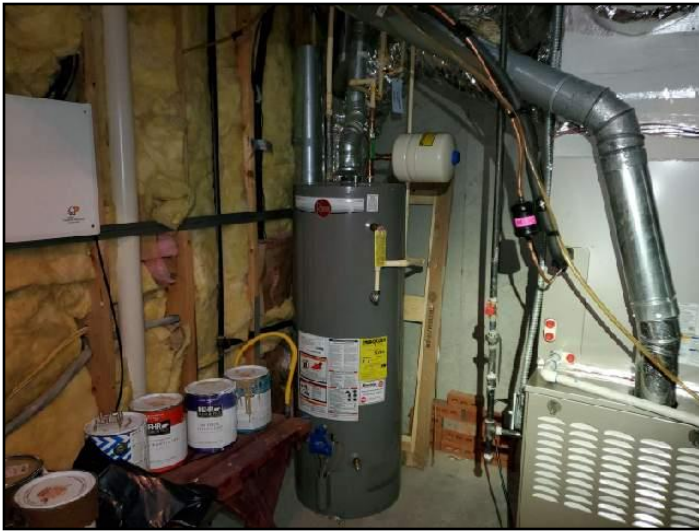
138. Rheem
